Elgin County Shoreline Management Plan

October 13, 2015
12251.101

W.F. Baird & Associates Coastal Engineers Ltd.

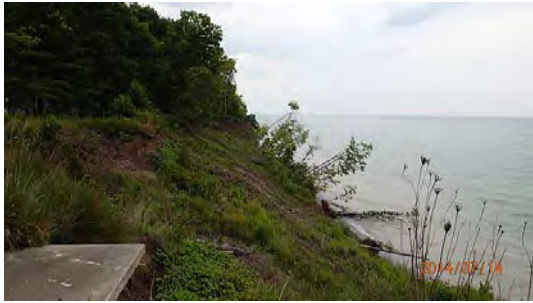
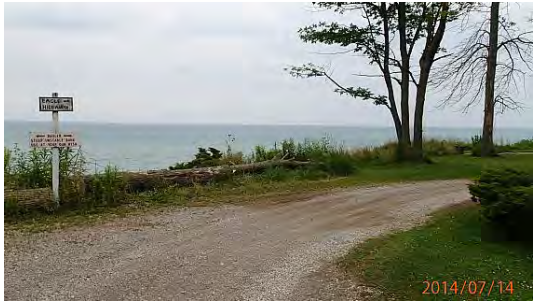
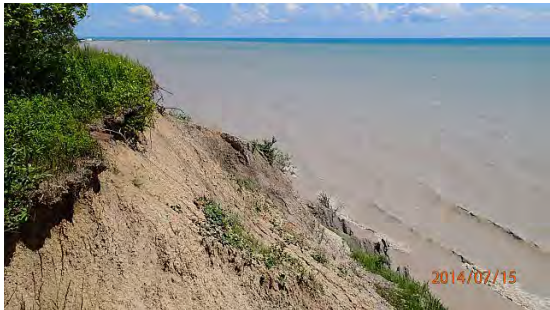
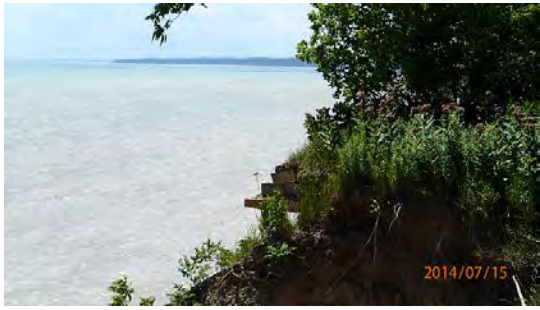
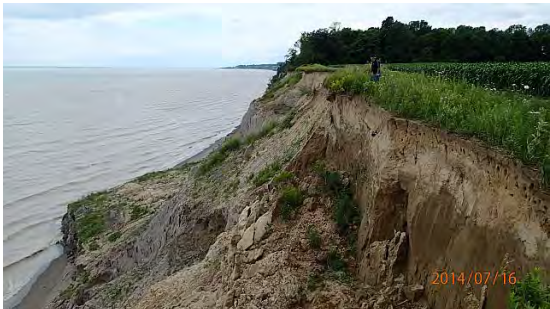
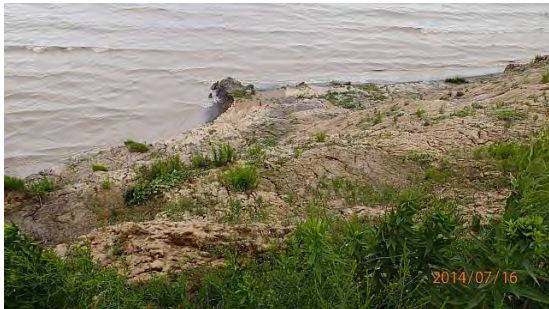
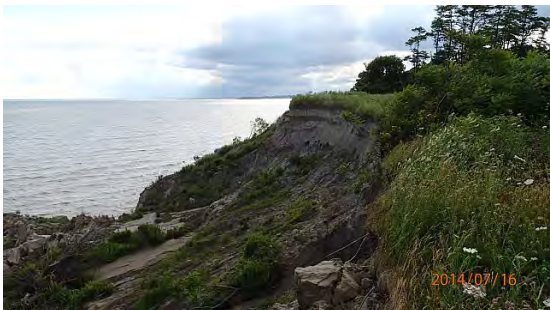
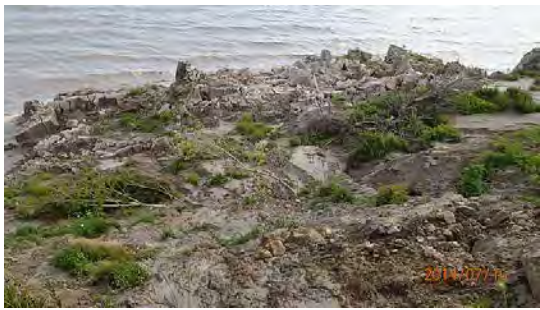
Figure 2.2 Typical Eroding High Bluff Sites

<p>Site 1: Eroding High Bluff (LTVCA)</p>

<p>Site 1: Road Along Bluff Crest (LTVCA)</p>

<p>Site 16: Eroding High Bluff (KCCA)</p>

<p>Site 16: Abandoned Foundation (KCCA)</p>

<p>Site 40: Eroding High Bluff (CCCA)</p>

<p>Site 40: Debris from Bluff Failure (CCCA)</p>

<p>Site 48: Eroding High Bluffs (LPRCA)</p>

<p>Site 48: Failure Debris (LPRCA)</p>

Pictures of typical eroding high bluff sites in the three other CAs are provided Figure 2.2. In addition, photographs of the other study sites are provided in subsequent chapters of this SMP.

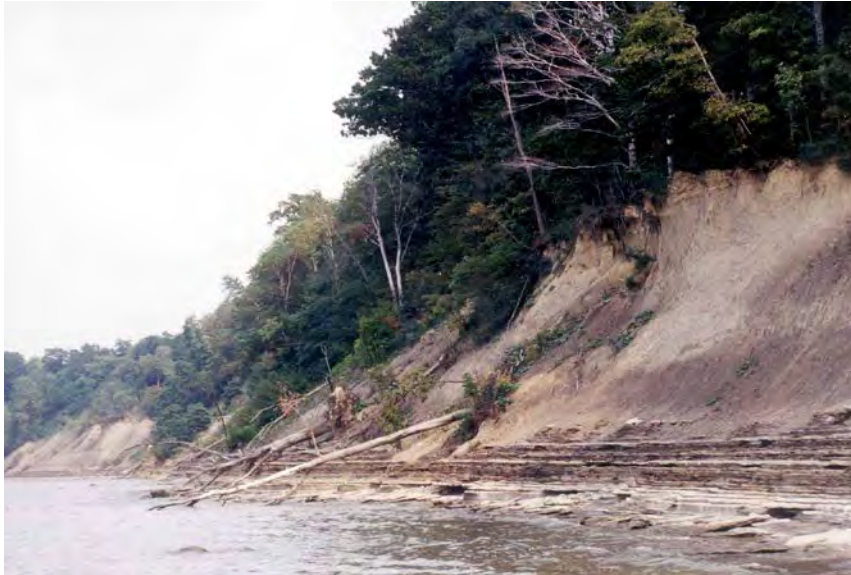
Figure 2.5 Typical Eroding Bedrock Shoreline (capped with cohesive sediment)

Figure 2.5 presents an alongshore view of a typical bedrock shoreline, located on the south shore of Lake Erie, east of Presque Isle (Baird, 2000). The nearshore lakebed and bluff toe have developed in weak shale and limestone. The shale is capped with glacial till, clay and sand. The eroding bluff face is void of vegetation, with the exception of fallen trees from the tablelands. While there are no major bedrock exposures along the shoreline in Elgin County, they are prevalent in the eastern basin of the lake. Therefore, the role of this shore type on littoral cells is reviewed.

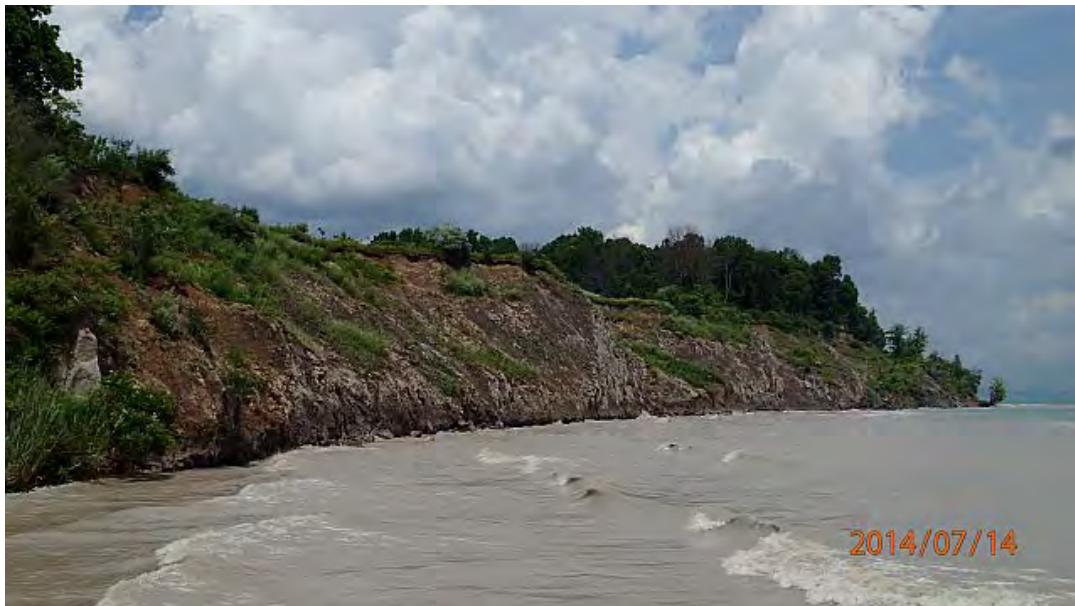
Figure 2.6 Eroding Cohesive Bluff (Site 6, east of Port Glasgow)

A shore is defined as cohesive when erosion of the consolidated shore materials, such as glacial till and glacio-lacustrine deposits, is the dominant process that shapes the morphology of the shoreline (Nairn and Holmes, 1988). Underneath any cohesionless deposits (i.e. sand and gravel), there is an erodible cohesive substratum, and the erosion of this material is the primary driving force that determines how and at what rate the shore evolves. Once the consolidated material is eroded, it cannot reconstitute itself in the energetic coastal environment, and therefore, cohesive shoreline erosion is irreversible. Since the fraction of sand and gravel is generally in the range of 5 to 25% of the soil matrix (Davidson-Arnott and Ollerhead, 1995), the volume of bluff erosion is not balanced by an equal amount of nearshore deposition. Intermittent deposits of sand and gravel may accumulate on the beach and in sand bars, while the remaining fine sediment (i.e. silts and clays) is transported in an offshore and alongshore direction (Bishop, et al., 1992). The majority of the study area is cohesive shoreline. A typical eroding cohesive bluff east of Port Glasgow is presented in Figure 2.6.

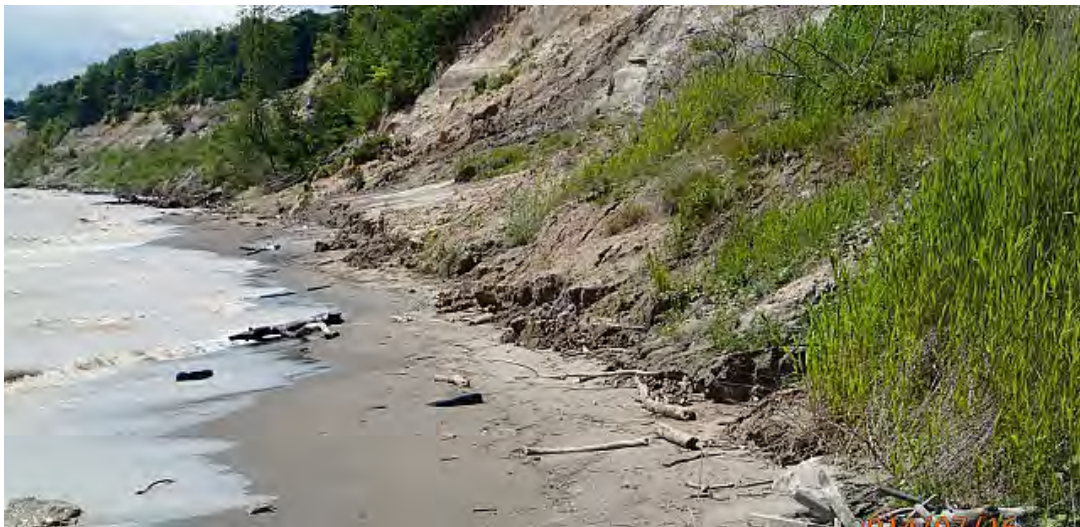
Figure 2.8 Toe Erosion due to Wave Attack (east of Port Bruce)

The physical factors that lead to toe erosion and removal of slumped debris will vary considerably depending on the stratigraphy of the site and the resistive properties of the toe sediments. Several processes have been identified, including: abrasion due to sediment entrained in waves and wave uprush; hydraulic and pneumatic pressures; turbulence due to wave breaking; and compression, tension, and cavitation (Carter and Guy, 1988; Amin and Davidson-Arnott, 1995). An example of toe erosion at the base of a cohesive bluffs east of Port Bruce is provided in Figure 2.8.

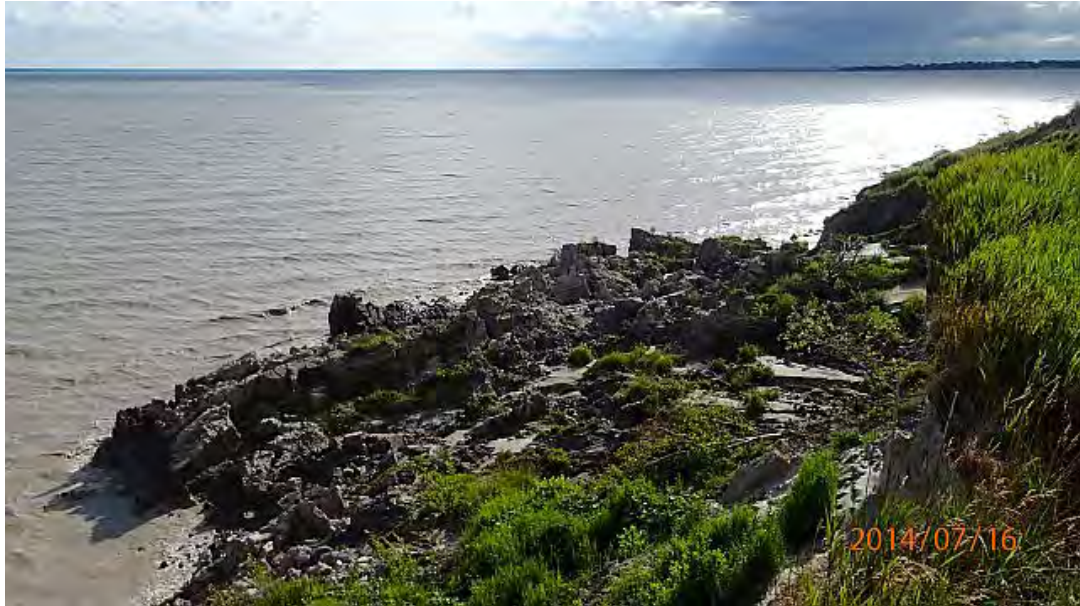
Figure 2.9 Debris from a Massive Bluff Failure East of Port Burwell

The site geology and geo-technical properties of the bluffs play a key role in the type of bluff failures due to wave induced toe erosion. For homogeneous bluffs, oversteepening at the bluff toe will ultimately lead to mass wasting events, such as block failures, debris flows, and shallow translational slides (Carter and Guy, 1988; Amin and Davidson-Arnott, 1995). For composite bluffs that feature complex stratigraphy and perched aquifers, toe erosion, in combination with softening, loss of effective stresses, high pore water pressures, and piping can lead to deep seated rotational failures and major landslides (Quigley et al., 1976; Eyles et al., 1986; Chase et al., 1996; Sterret and Edil, 1982). A picture of a massive rotational failure at Site 48 east of Port Burwell is provided in Figure 2.9.

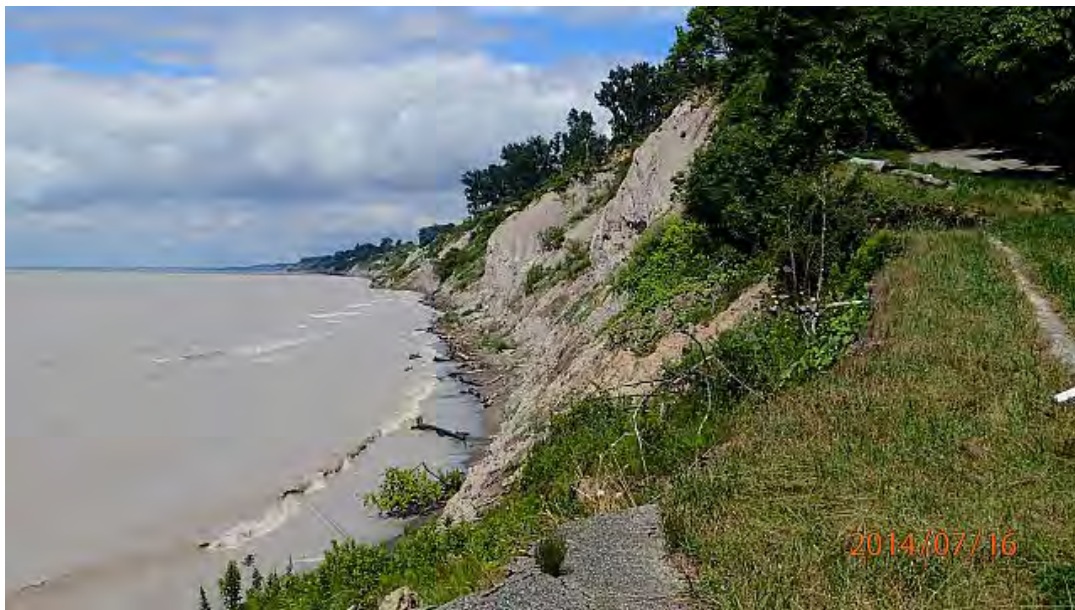
Figure 2.11 Eroding Cohesive Shore West of Port Bruce

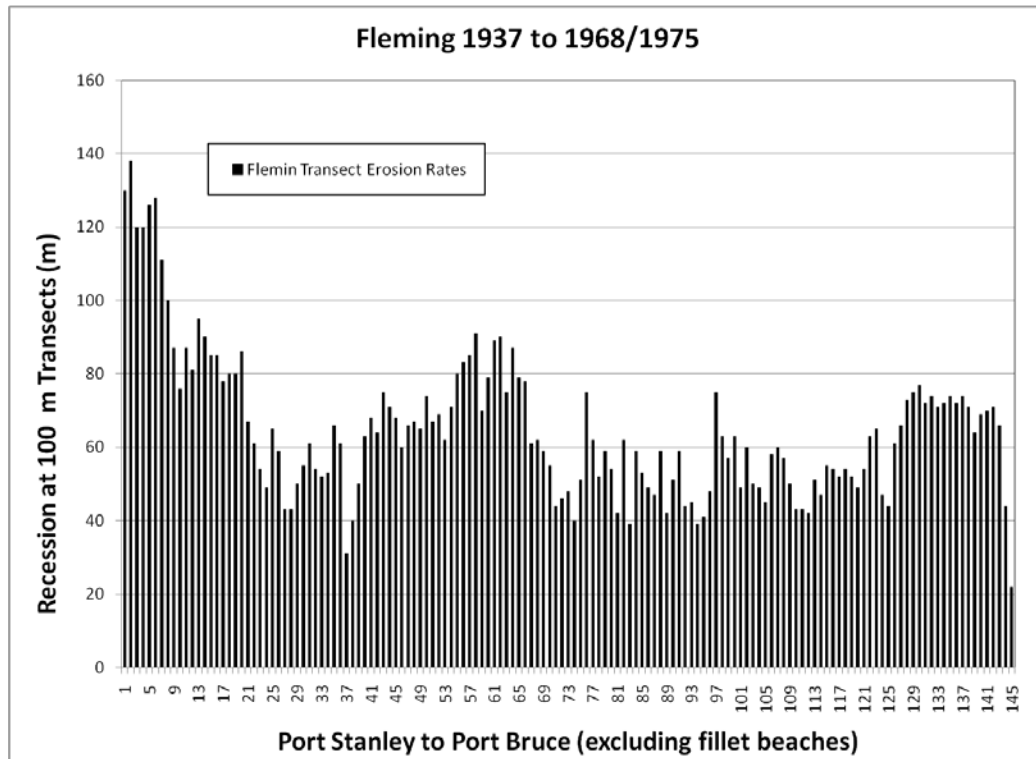
Figure 2.16 Recession Measurements at Individual Transects from Port Stanley to Port Bruce

When measuring historical erosion rates across a regional area, such as Port Stanley to Port Bruce, individual transect measurements such as the 100 m Fleming (1983) data have historically been averaged together to produce one average annual recession rate (AARR) for the stretch of coastline. The logic behind the AARR was to smooth the data and remove the local variability. The AARR for the Fleming (1983) data, 1.9 m/yr, was added to Figure 2.17. Interestingly, very few of the historical recession rates actually correspond to the average due to the large amount of spatial variability in the rates. Since the historical AARR is used in setback planning as an estimate of the future erosion rate for a given area, the results in Figure 2.17 suggest it may not be a good predictor. In other words, if very few of the bluffs eroded at the AARR historically, there is no guarantee they will erode at a rate equal to or similar to the AARR in the future. Fortunately, the Technical Guide (MNR, 2001a) recommends the AARR is the minimum rate for setback planning and therefore a different approach will be required for this SMP.

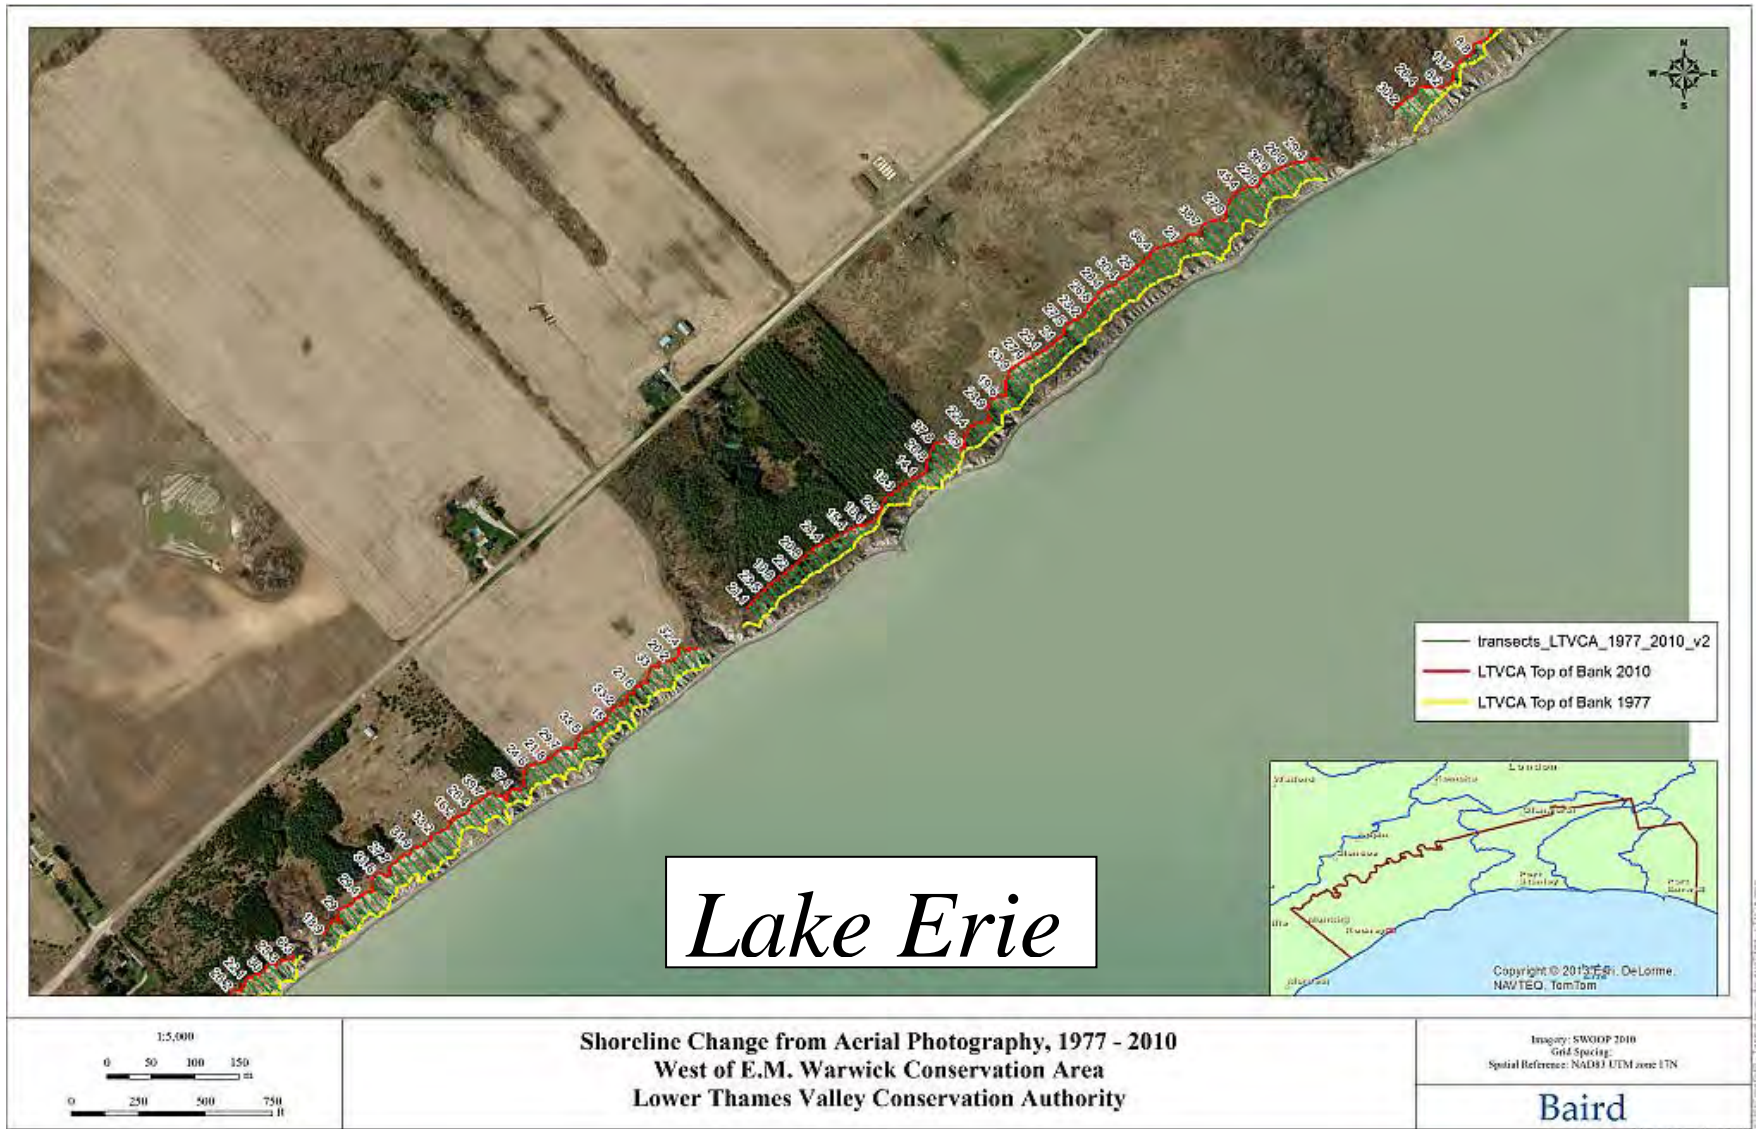
Figure 2.19 1977 to 2010 Erosion Measurements West of E.M. Warwick Conservation Area, LTVCA

- Figure 2.19: A total of 173 erosion transects, featuring an AARR of 0.7 m/yr and an AASD of 0.3 m/yr.
- Figure 2.20: A total of 32 erosion transects, featuring an AARR of 1.6 m/yr and an AASD of 0.3 m/yr.
- Figure 2.21: The 1977 and 2010 imagery and bluff crest position northeast of Duttona Beach. A total of 183 transects, featuring an AARR = 0.48 m/yr, AASD = 0.22 m/yr.
- Figure 2.22: The Baird erosion transects are plotted in chronological order west to east (black diamonds) and in ascending order (grey diamonds). The spatial variability observed in Fleming (1983) and discussed in Section 2.4.1 was also observed in these Baird measurements. And similarly, the AARR +/- 2SD encompasses the majority of the results (i.e., greater than 95%).

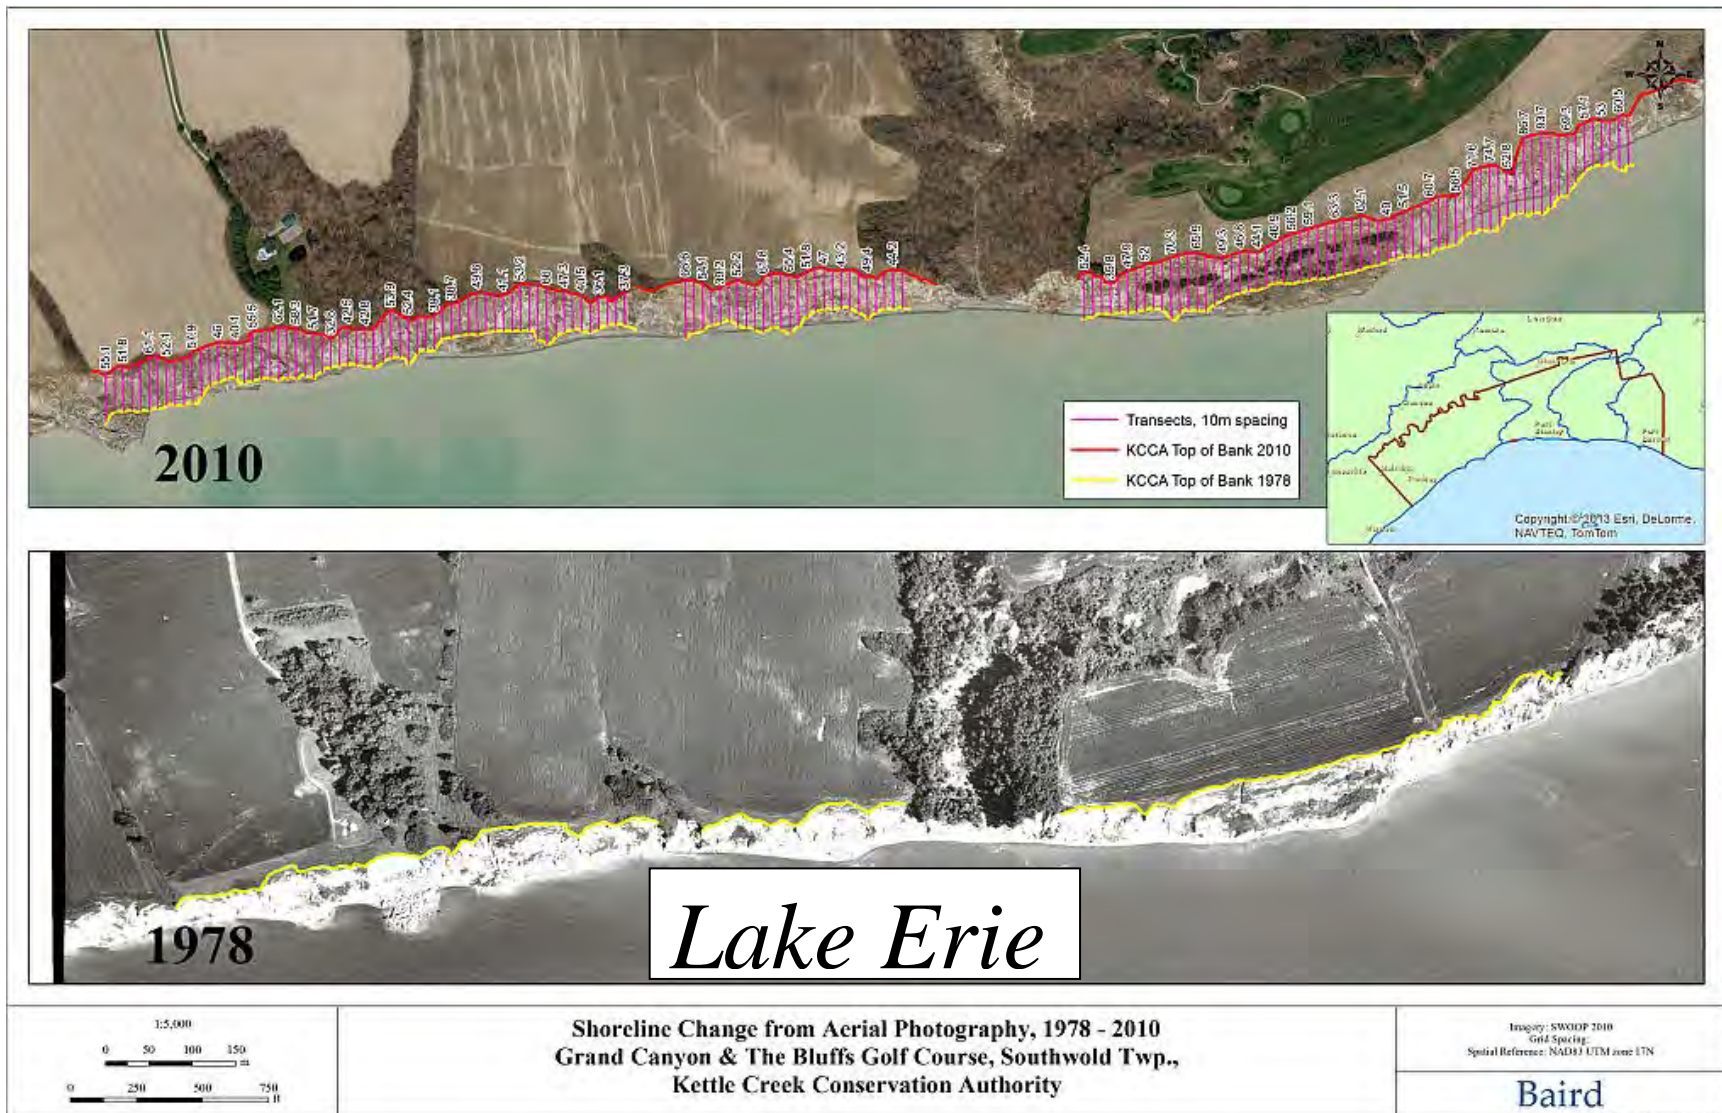
Figure 2.23 1978 to 2010 Erosion Measurements at Grand Canyon and the Bluffs Golf Course, KCCA

- Figure 2.23: A total of 151 erosion transects, featuring an AARR of 1.6 m/yr and a SD of 0.3 m/yr.
- Figure 2.24: A total of 165 erosion transects, featuring an AARR of 1.7 m/yr and a SD of 0.3 m/yr.

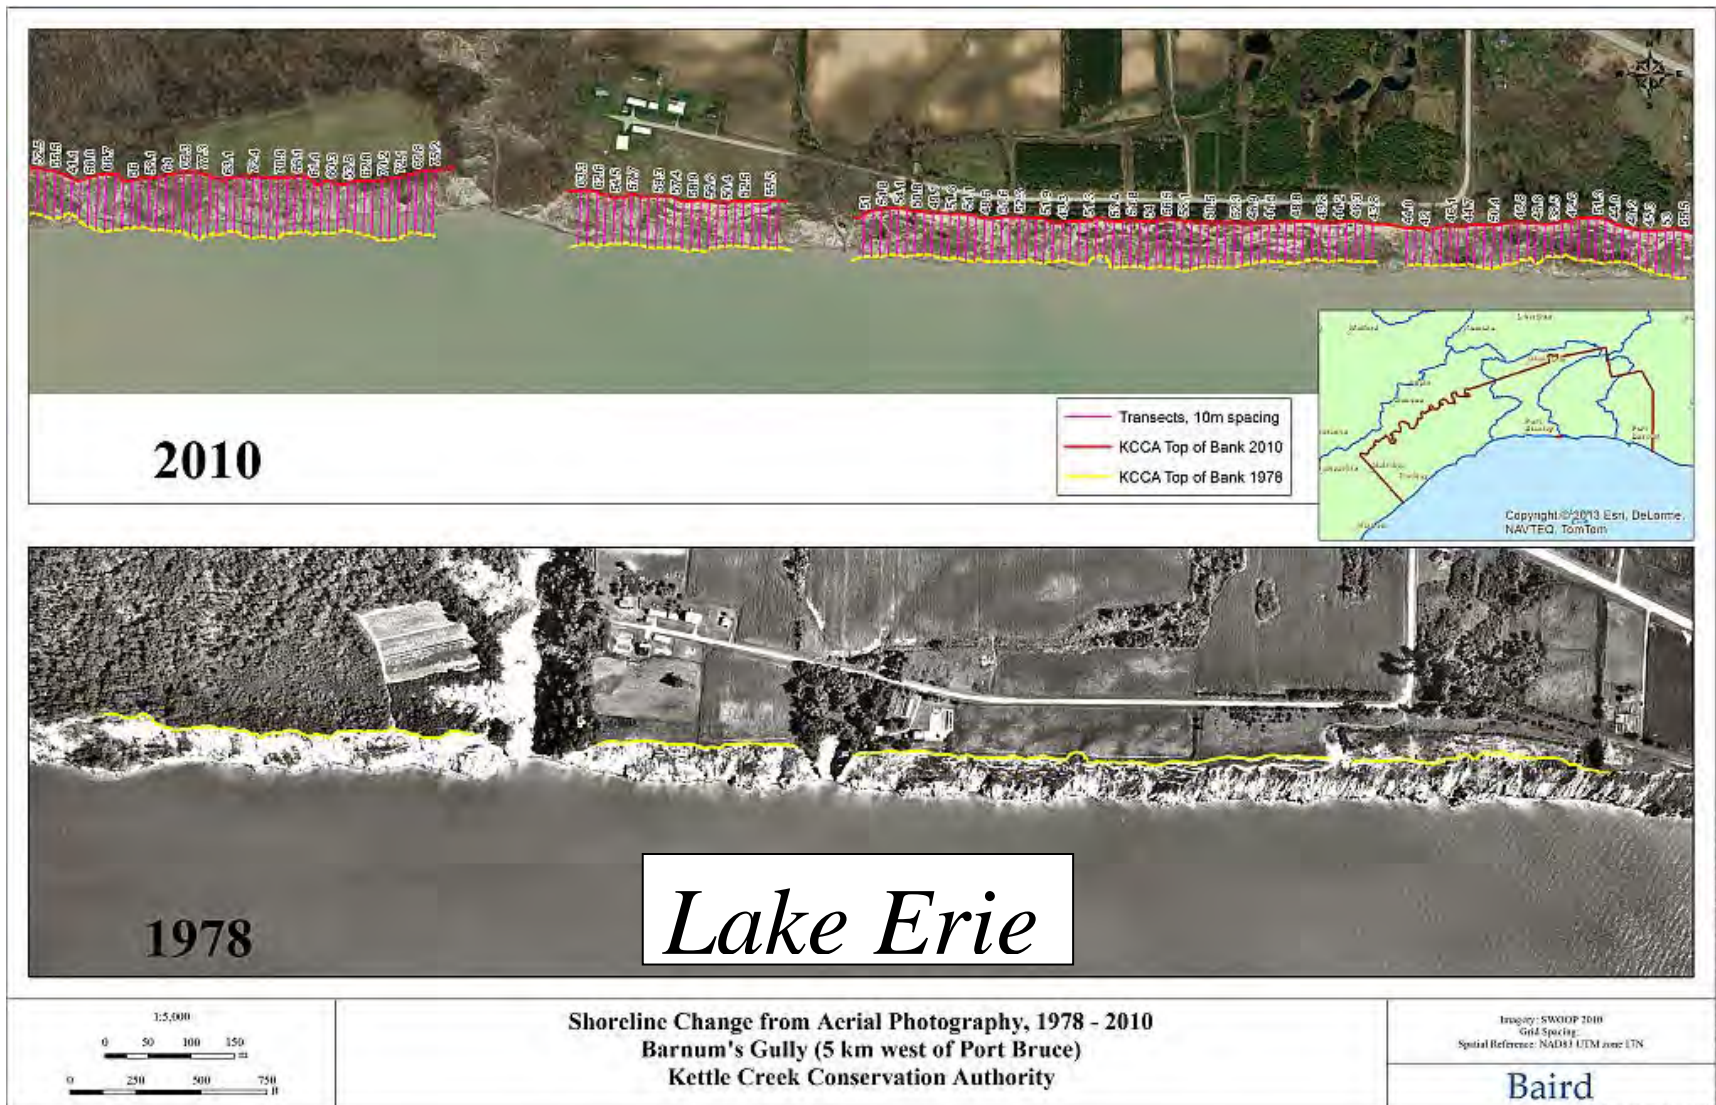
Figure 2.24 1978 to 2010 Erosion Measurements at Barnum's Gully, KCCA

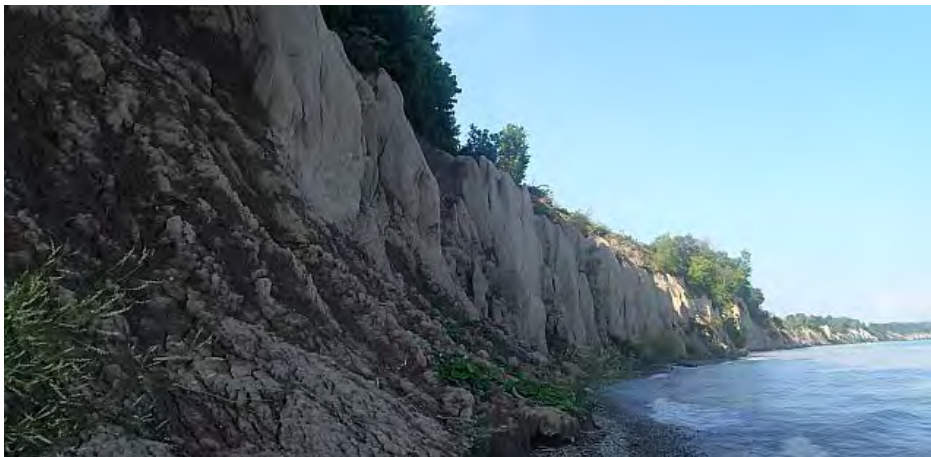
Figure 2.34 Glacio-lacustrine Bluffs West of Port Stanley

Several of the 51 study sites were re-visited with geotechnical engineering staff from Terraprobe on October 9, 2014. West of Port Stanley, the eroding bluffs consist of glacio-lacustrine sediment with a high silt and clay content. This sediment was deposited in a glacial lake environment and is partially to fully consolidated. Therefore, many sections of the bluff are able to maintain a steep slope before they fail, as seen in the distance of Figure 2.34. Fractures in the bluff face can lead to large failures or topples, as pieces of the bluff face break off and fall into the lake. The soil can also lose its cohesive properties, often during heavy rainfall events or spring thaw events when the clay particles in the sediment absorb water. Eventually, the sediment absorbs too much water and turns into flowing sediment, spilling onto the beach as seen in the forefront of Figure 2.34.

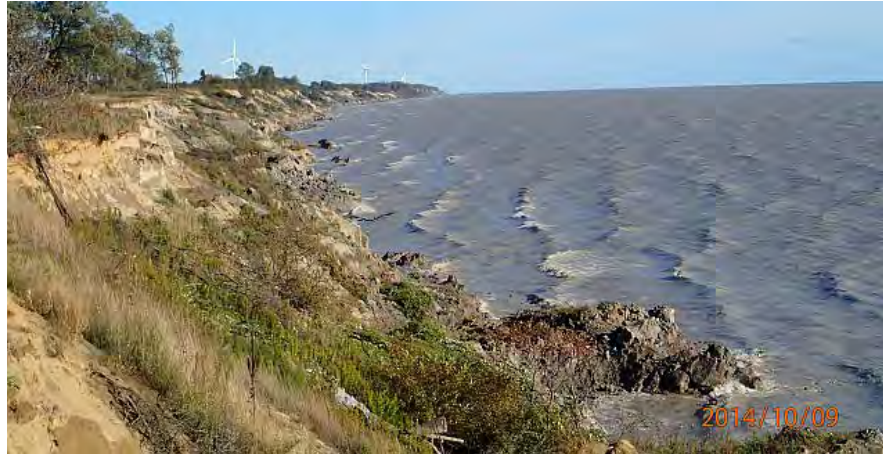
Figure 2.35 Eroding Bluffs at Site 48

East of Port Stanley, the majority of the eroding bluffs consist of a sandy lacustrine clay, with significantly less silt and clay compared to the soils to the west. Due to the sand content in the soil, there is less cohesive strength and the sediment is only partially consolidated. The constant wave attack at the toe of these bluffs keeps the bluff face in a constant state of instability. Slides and rotational slope failures result in large debris fans at lake level, as seen in Figure 2.35. In many cases, the slope failures are described as progressive, since the waves and currents are not able to fully erode the debris from the first failure before the second failure occurs and mixes with the first.

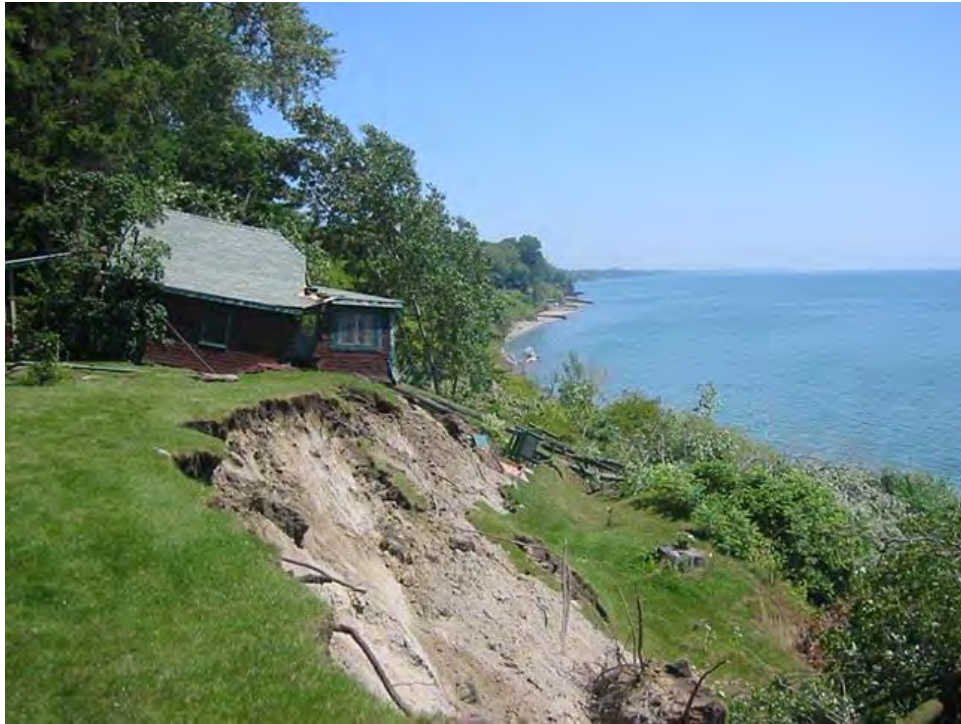
Figure 3.1 Home Destroyed by Bluff Failure in the LTVCA (photo courtesy of the LTVCA)

When development is located on the tablelands of an eroding bluff, eventually the structural stability of the buildings will be compromised due to slope instability issues. And if not relocated, the building will eventually be destroyed, as was the case for the home in Figure 3.1. The home was eventually destroyed during a large slope failure.

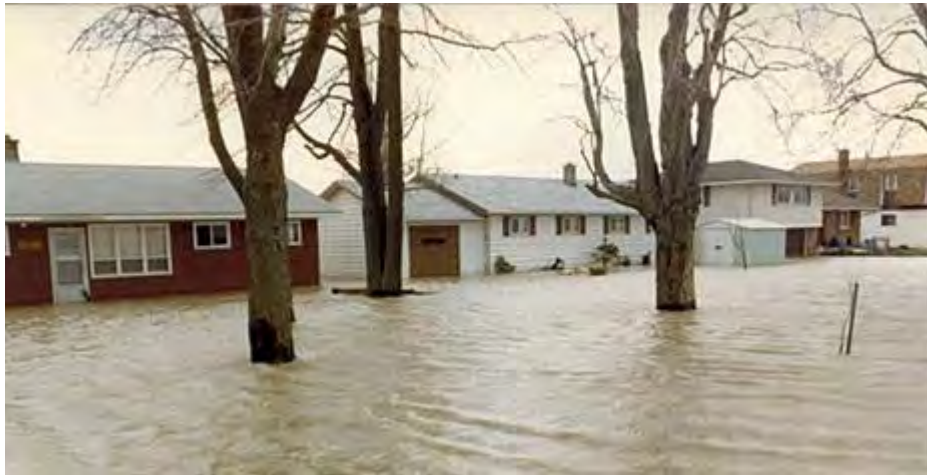
Figure 3.4 Coastal Flooding in the LTVCA Watershed (photo courtesy of LTVCA)

Coastal flooding in Elgin County is primarily focused on the low lying Port Communities, as infrastructure located on the tablelands above the bluff crest is not susceptible to flooding hazards. Refer to Figure 3.4 for an example of coastal flooding in the Lower Thames Valley Conservation Authority. The definition and mapping procedures to delineate the flooding hazards are described in the following sections.

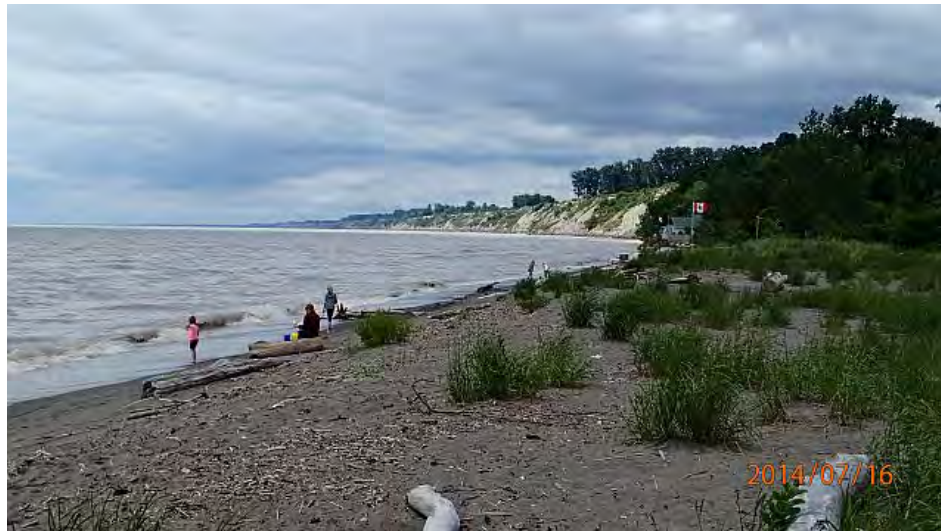
Figure 3.6 Dynamic Beach west of Navigation Channel in Port Bruce

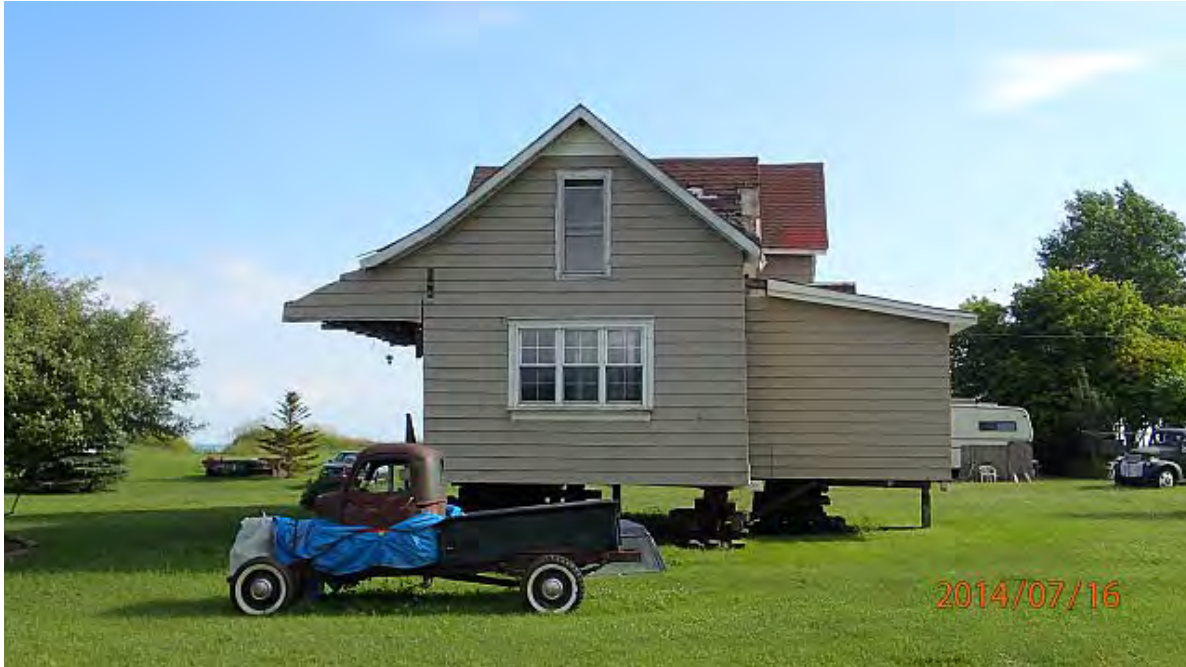
Figure 4.2 Home on Temporary Piles (assumed relocation due to bluff recession)

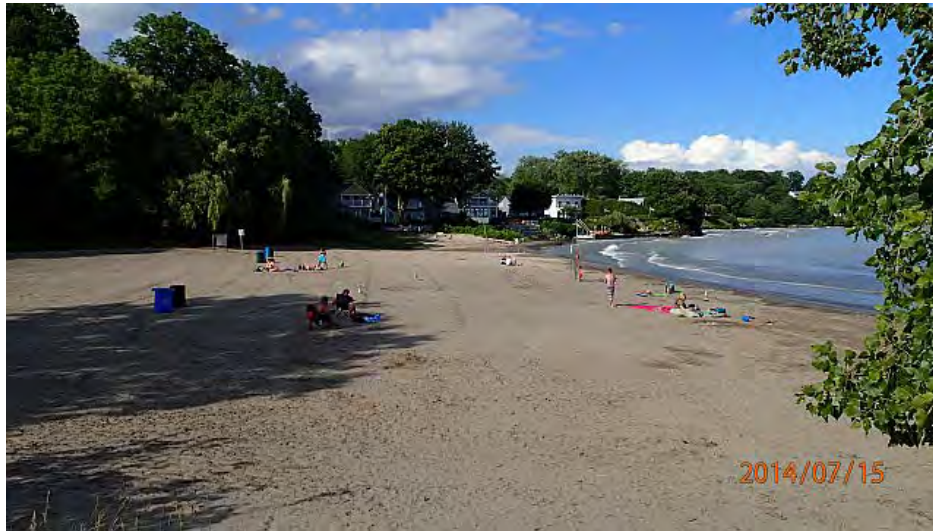
Figure 4.3 East Fillet Beach at Port Stanley

Each of the four Port Communities feature jettied navigation structures, which protrude into the lake varying distances (e.g. 80 to 1,500 m). These structures have disrupted the natural flow of sediment along the coastline and trapped sediment in fillet beaches locally. Over time, two Provincial Parks (Port Bruce and Port Burwell) were established on these artificial beach deposits. Others, such as eastern and western fillet beaches in Port Stanley (Figure 4.3 and Figure 4.4 respectively) are popular public access nodes to the Lake Erie coastline.

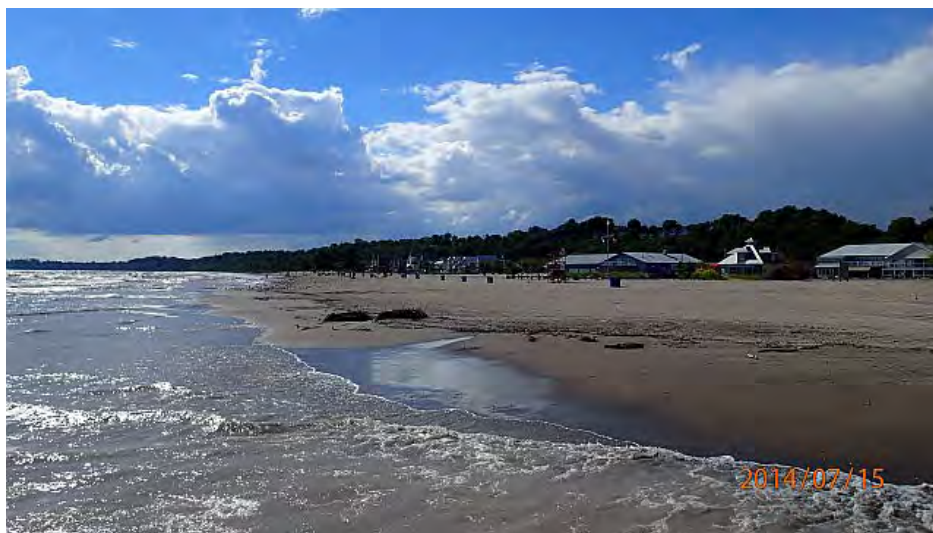
Figure 4.4 West Fillet Beach at Port Stanley

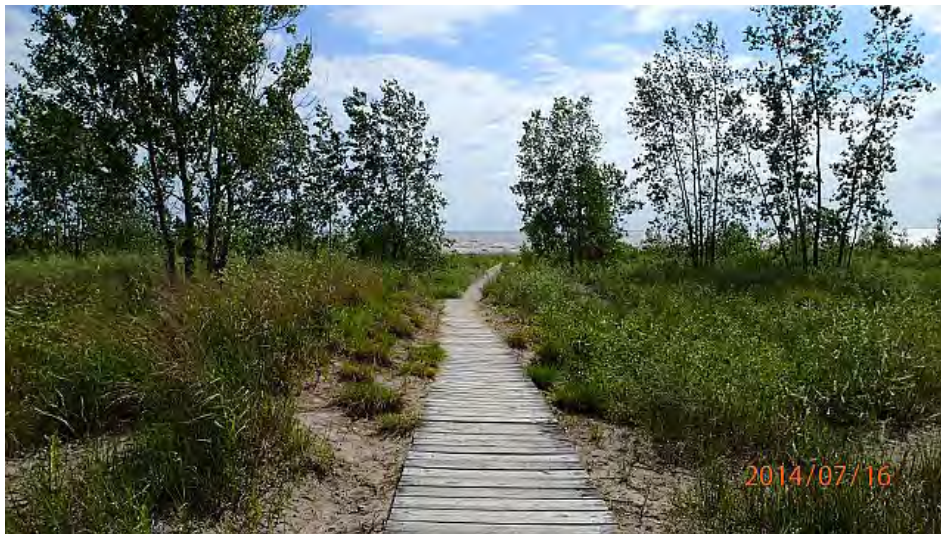
Figure 4.5 Wooden Boardwalk at Port Burwell Provincial Park

Coastal dunes are an important component of beach ecosystems in the Great Lakes and thus they should be protected from unnecessary foot traffic by beach users. Focusing access to the beach at select nodal areas with boardwalks over the dunes is an effective strategy. Refer to Figure 4.5 for a picture of a wooden boardwalk at the Port Burwell Provincial Park used to focus foot traffic and protect the fragile plant communities in the dunes.

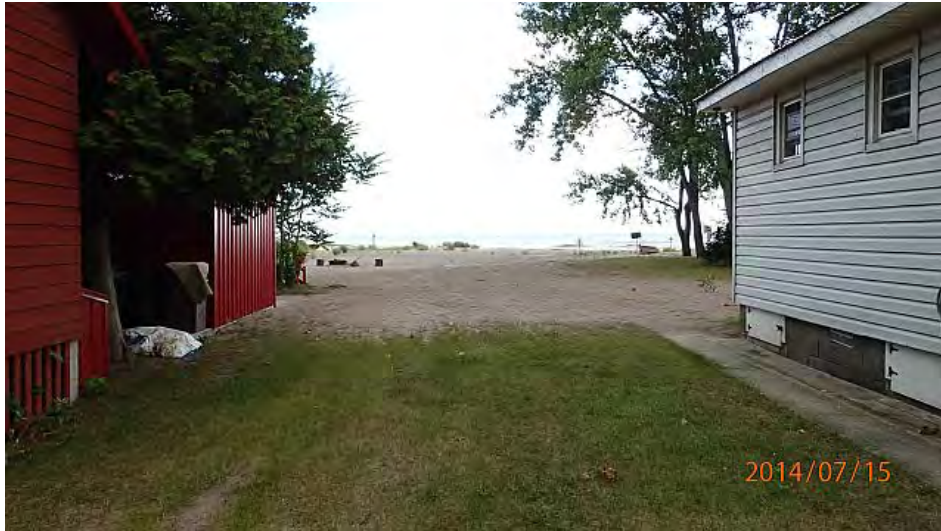
Figure 4.6 Port Stanley Beach Development with no Dune (looking south)

The significance of these dune environments is the basis for the Dynamic Beach Standard and the protection they receive from future development. However, in some locations with dense development, such as the western fillet beach in Port Stanley, the dunes have been modified or removed. Refer to Figure 4.6. In addition to the important habitat the dunes provide, they also protect development from flooding hazards. If the dune in one location has been removed, it increases the vulnerability of the entire area to coastal flood risks. In such locations, the local governments and CAs should encourage local riparian landowners to restore the coastal dunes.

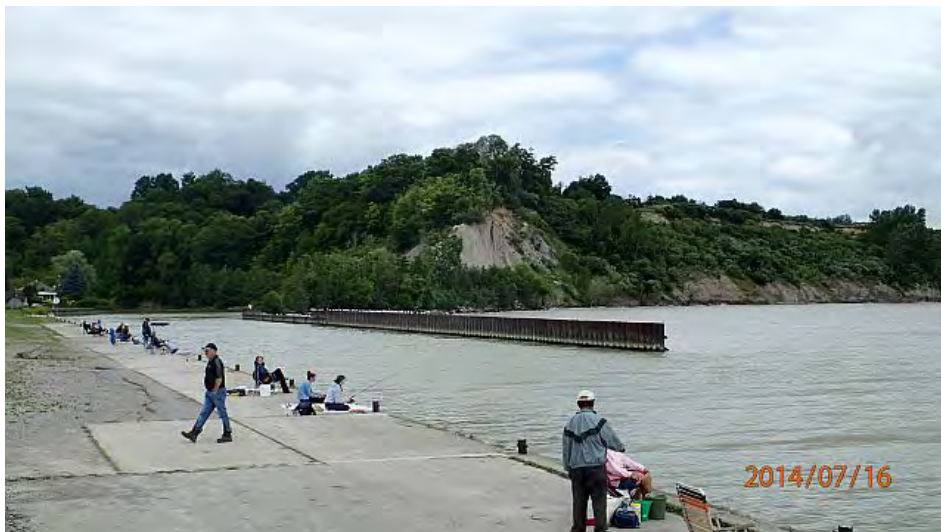
Figure 4.7 View of Port Bruce Jetties and Navigation Channel Looking Upstream

The jettied navigation structures in the four port communities were initially constructed to improve navigation into the rivermouths and marina basins for commercial vessels and local fishing fleets. The safe refuge from Lake Erie storms provided the catalyst for further development of the port lands and they have supported a variety of industries (e.g. fish processing) and more recently recreational boating. Refer to Figure 4.7 for a picture of the navigation channel in Port Bruce.

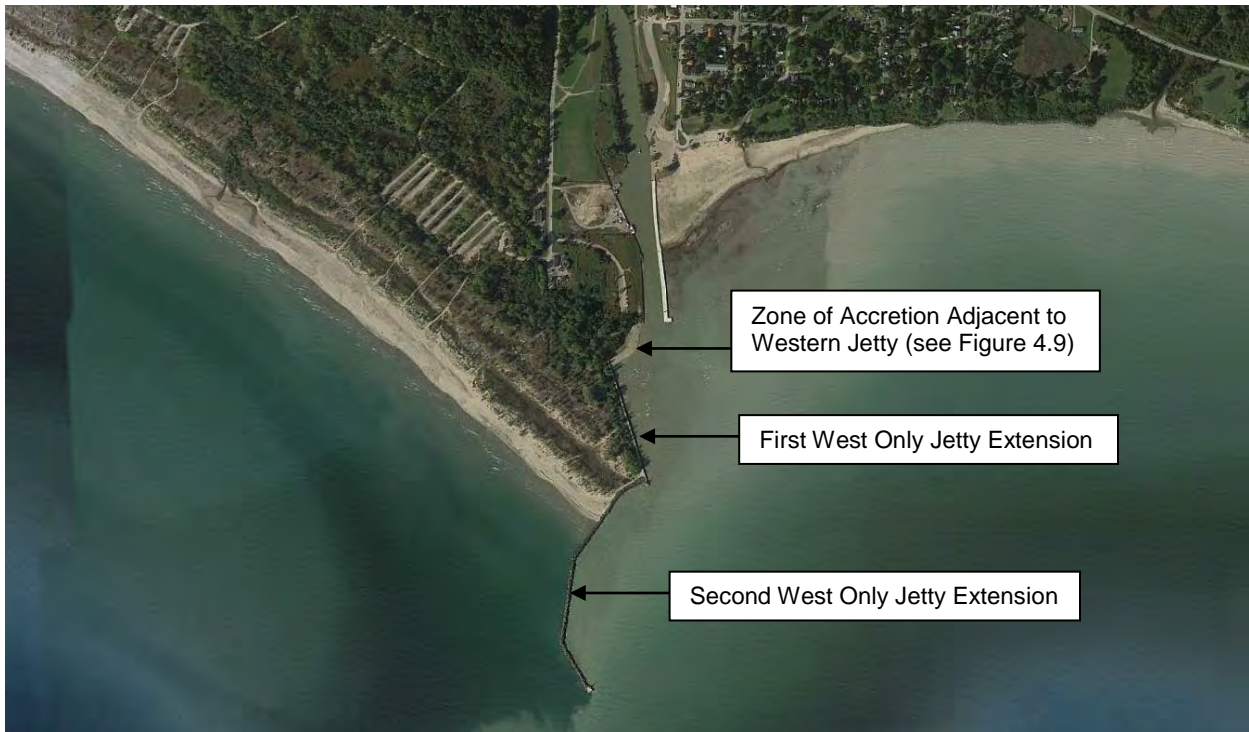
Figure 4.8 Port Burwell

For example, at Port Burwell, it would appear the western jetty has been extended on two occasions while the length of the eastern jetty remains unchanged. Refer to Figure 4.8. This single jetty expansion approach at Port Burwell has continually increased the trapping potential of the western structures, while leaving the navigation channel susceptible to sedimentation during storm events from the east. Based on field observations, one zone of sediment accumulation is noted in Figure 4.8 (aerial view) and with a ground level photograph in Figure 4.9. These historical management decisions are not consistent with the objectives of this SMP and in the future a more holistic decision making framework that relies on the principles of ecosystem based management is required when modifying the engineering structures at the ports.

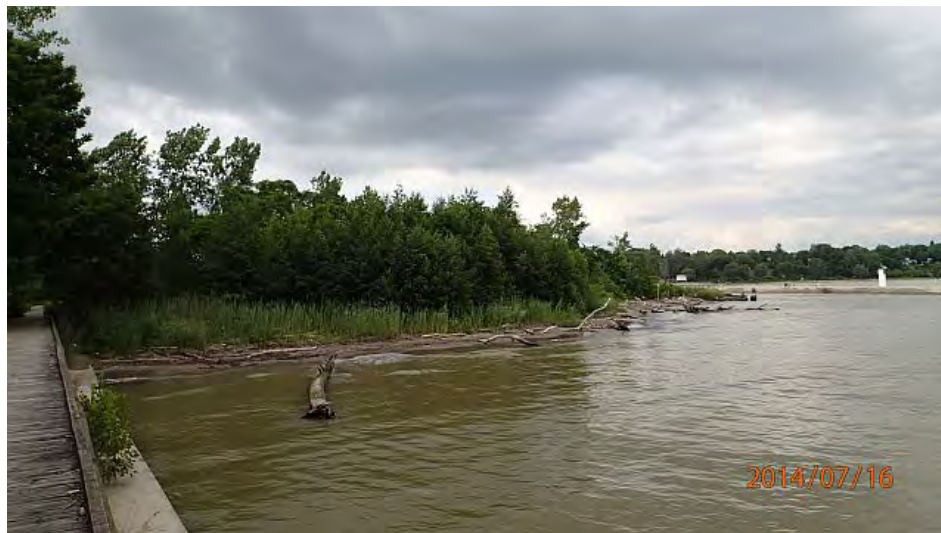
Figure 4.9 Zone of Sedimentation Adjacent to the West Jetty

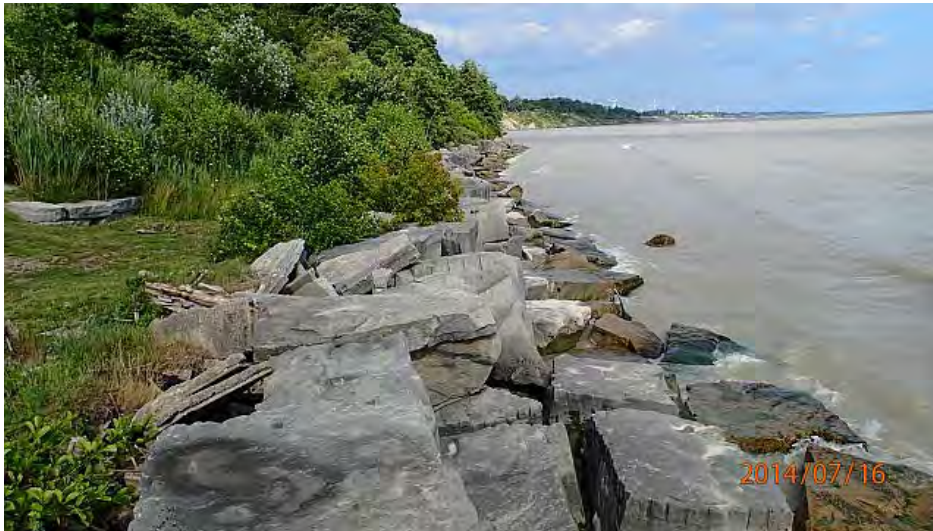
Figure 4.11 Armour Stone Revetment East of the Navigation Channel, Port Burwell

A picture of the revetment east of the navigation channel in Port Burwell is presented in Figure 4.11. This structure is approximately 500 m in length and followed by another smaller revetment or ad hoc structure at the creek mouth to the east. Based on discussions with the Technical Advisory

Committee, the ownership of this structure is not known and thus it seems unlikely routine maintenance is being completed. The ownership of this structure and other similar installations in Elgin County should be determined. A digital database noting the type and spatial location of all shoreline protection structures, including this revetment, was assembled as part of the background data collection for this SMP. This digital database could be expanded to include ownership and a point of contact information, thus serving as a useful tool to ascertain responsibility for future maintenance.

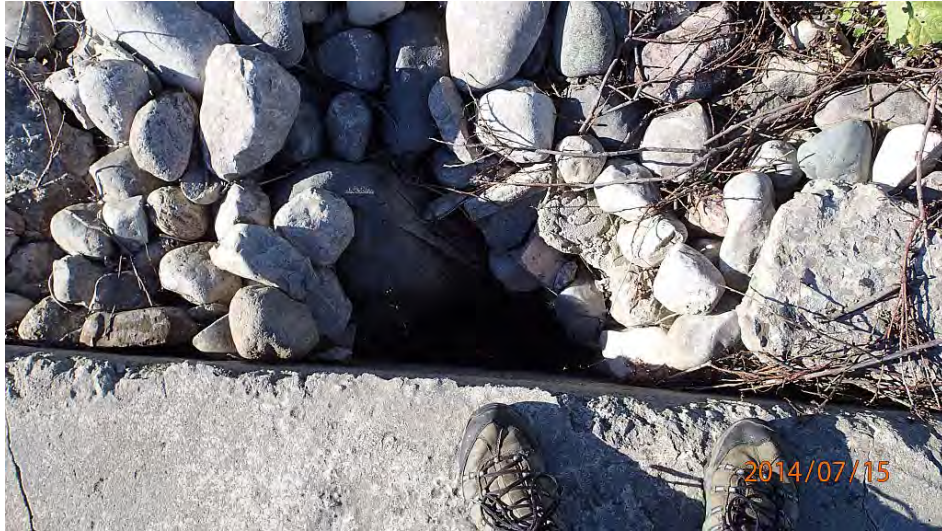
Figure 4.12 Cavity Behind a Concrete Block Wall in Port Stanley
