Elgin County Shoreline Management Plan

October 13, 2015
12251.101

W.F. Baird & Associates Coastal Engineers Ltd.

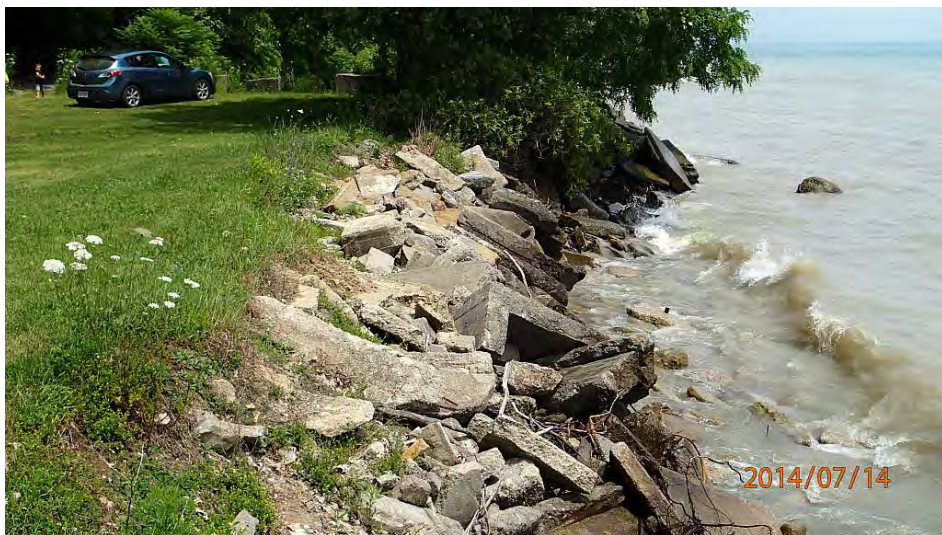
Figure 4.13 Ad Hoc Concrete Rubble Protection in Port Glasgow

Engineering structures will also fail due to age, which is referred to as degradation failures, since they were not designed to last forever. Refer to the dumped concrete rubble structure in Port Glasgow, as seen in Figure 4.13. Over time the concrete pieces will break, crumble and slide downslope, leaving the upper bank exposed to wave activity. Signs of crest erosion are evident in Figure 4.13 and it is important to note we have been in a period of low to average water levels on Lake Erie since 1999. During storms at high lake levels, these structures are more vulnerable to shore erosion. Given that there is no engineering design component to these ad hoc structures, they should be inspected regularly by the owners (e.g. monthly).

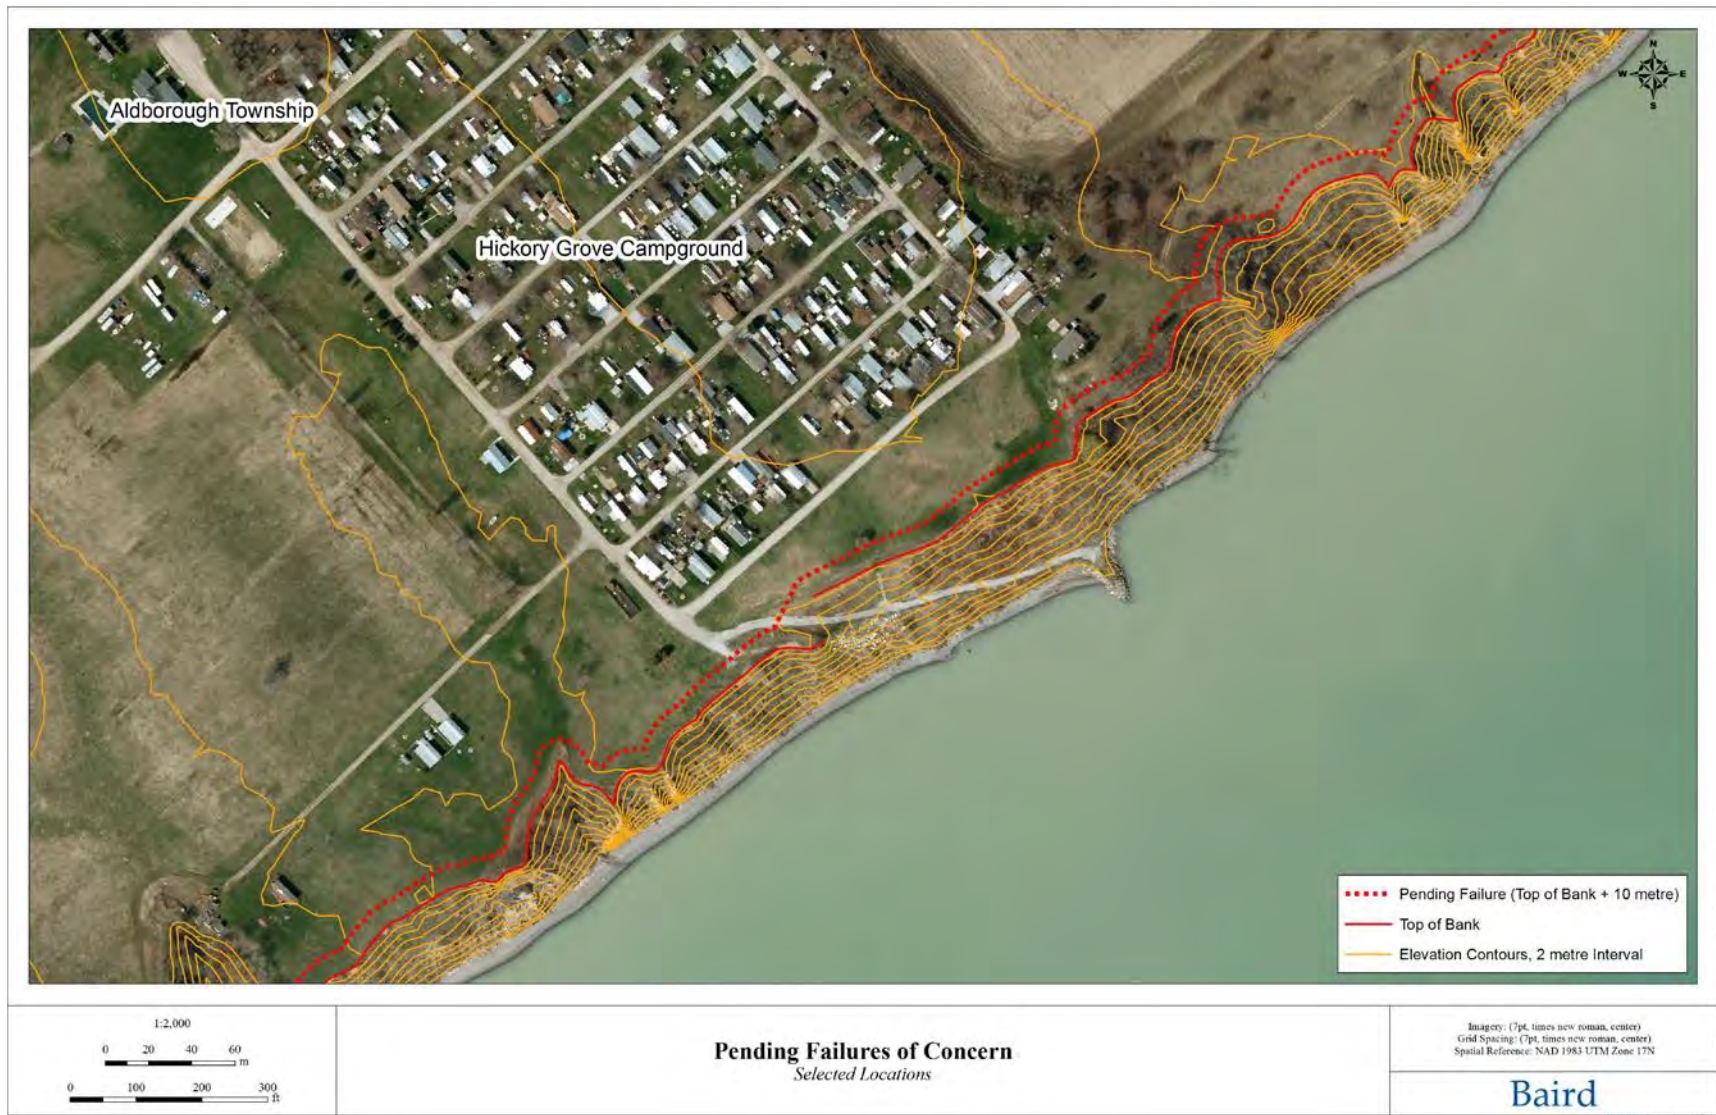
Figure 4.15 Zone of Pending Failure at Hickory Grove Campground, Municipality of West Elgin

At the Hickory Grove Campground in the Municipality of West Elgin, a large buffer strip exists between the exiting bluff crest and the first row of trailers. See Figure 4.15. Presently, this buffer protects the trailer park from any immediate dangers associated with bluff failures and there are no structures in the Zone of Pending Failure.

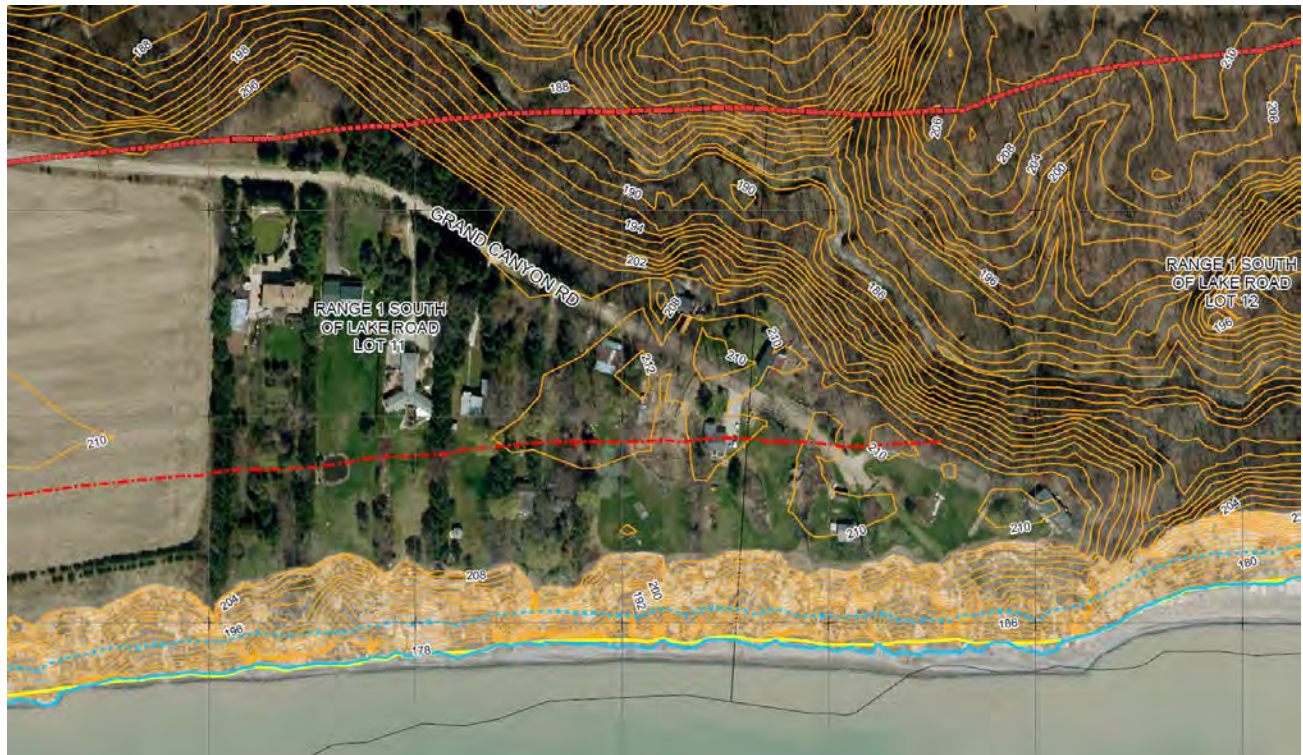
Figure 4.16 Zone of Higher Risk, Grand Canyon Road, Township of Southwold

Based on the geotechnical review completed for this study, all the tablelands within the 3:1 stable slope setback have been classified as a Zone of Higher Risk. In other words, there is a high probability these tablelands will erode, as the slope materials are unstable at an inclination steeper than 3:1. A total of 115 primary buildings and 55 secondary buildings are located within this zone of higher risk in Elgin County. A database of the building centroids was generated as a deliverable for this SMP update. Further details on the location of these buildings are provided in subsequent sections of this SMP.

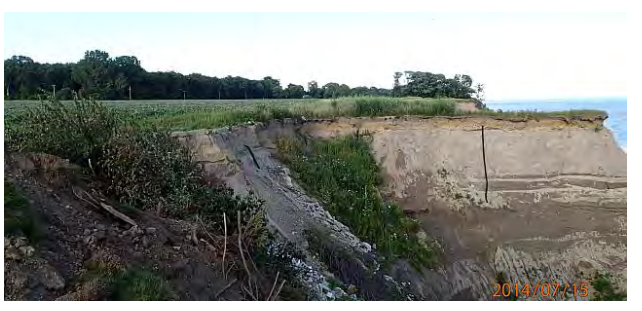
AGRICULTURAL LAND USE ALONG BLUFF CREST	
<p><u>DON'T:</u> Crop right to the edge of the bluff crest</p> <ul style="list-style-type: none"> -avoid cultivating land and cropping right to the bluff crest -maintain tile drain outlets so they don't drain down the bluff face. Should outlet at beach level

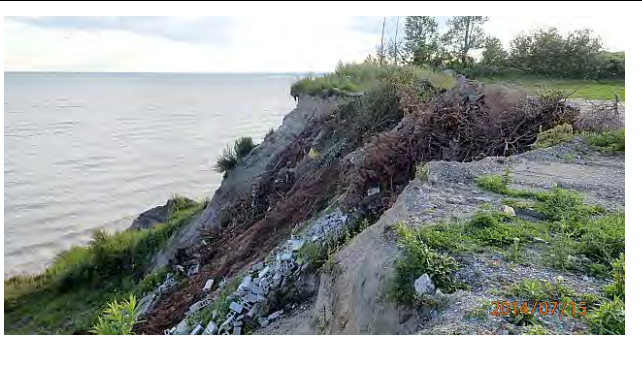
<p><u>DON'T:</u> Dump rubble and debris over the bluff crest</p> <ul style="list-style-type: none"> -debris on the bluff crest will not mitigate slope erosion. In fact, it could accelerate the erosion process by surcharging (adding weight) to the slope and blocking groundwater discharge locations -the debris will eventually end up in the lake and pollute the nearshore environment, which is critical habitat and the source of our drinking water

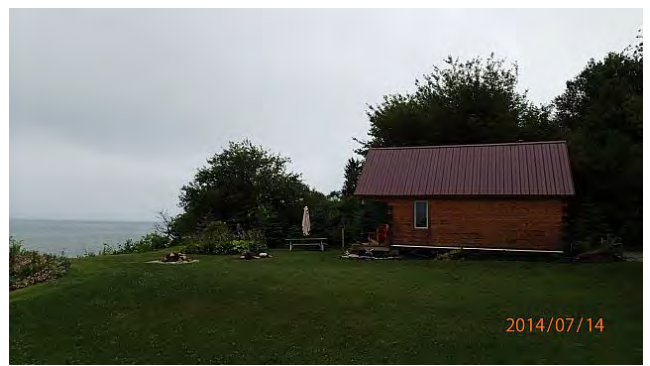
DON'T: Locate Permanent Structures Close to the Bluff Crest

-large permanent buildings can surcharge the bluff crest and initiate slope failures. These types of structures should be located landward of the erosion hazard limit

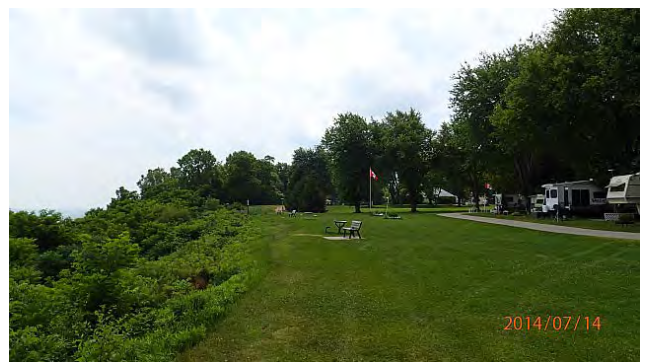
DO: Maintain a Vegetated Buffer Strip between Movable Buildings/Trailers and Promote Vegetation on the Bluff Slope

-maintain a vegetated buffer between the bluff crest and movable structures, such as trailers
 -monitor changes in the bluff crest position and have a retreat plan in place to re-locate structures when they are within the 3:1 (H:V) stable slope allowance

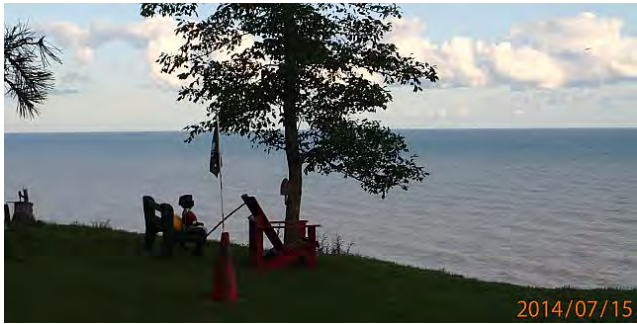
TEMPORARY USAGE OF BLUFF CREST	
<p><u>DON'T:</u> Occupy the Bluff Crest for Any Reason</p> <ul style="list-style-type: none"> -the bluffs can fail at any time and these failures cannot be predicted -the bluff crest should not be used for any reason, even passive day use

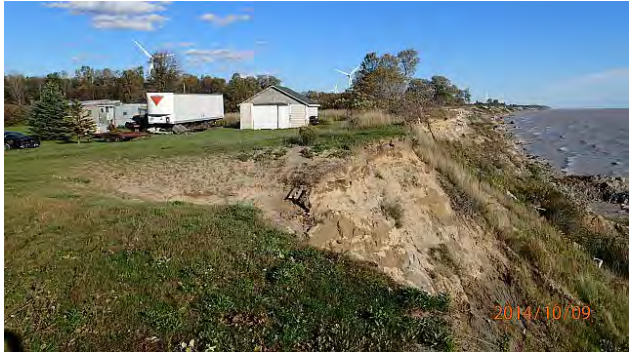
PROMOTE NATURAL/NATIVE VEGETATION ALONG BLUFF CREST AND ON SLOPE	
<p><u>DON'T:</u> Maintain a Mowed/Manicured Lawn Right to the Bluff Edge</p> <ul style="list-style-type: none"> -without water absorbing native shrubs and trees, water from rainfall events flows quickly to the bluff edge and leads to slope failures -lawns have shallow root systems and don't bind together the soil

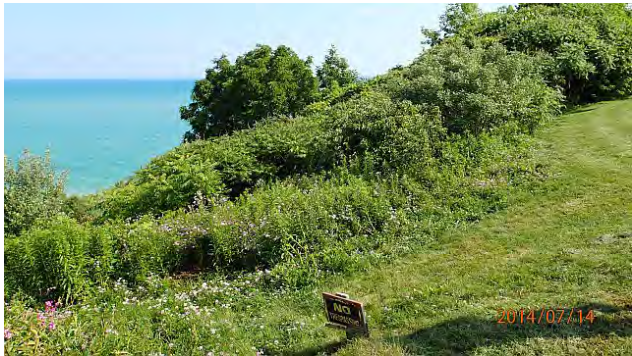
<p><u>DO:</u> Encourage Native Vegetation on the Bluff Crest and Slope</p> <ul style="list-style-type: none"> -plant water tolerant native vegetation on the crest and slope to absorb moisture (e.g. Sumacs and Dogwoods)

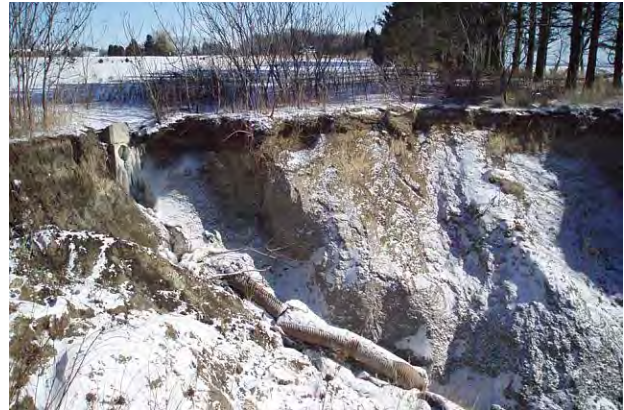
DON'T: Underestimate the need for monitoring and maintenance following construction

- the drainage schemes will not function without regular maintenance due to the high bluff erosion rates in Elgin County
- do not design and/or construct a project without professional engineering support

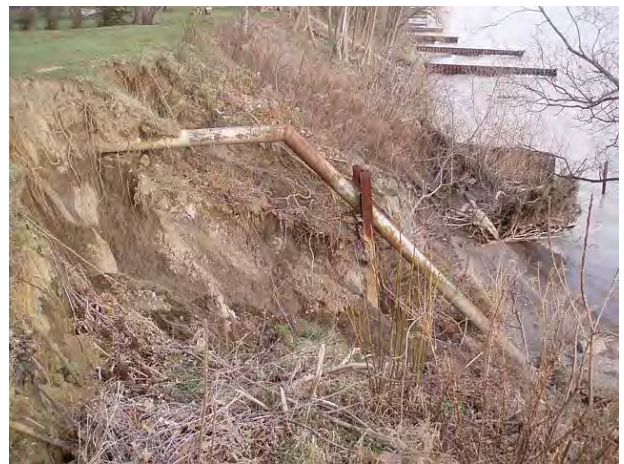
DO: Regularly inspect the drainage scheme, budget for future maintenance, and implement repairs

- regular monitoring for all drains that traverse the bluff slope should be implemented by the owner
- ensure the water is conveyed to the beach, not down the bluff slope
- maintenance costs should be factored into the initial capital budget to ensure funds are available for the inevitable repairs
- have a contingency plan to address failure of the drainage scheme following a bluff erosion event
- seek professional engineering services to design and implement maintenance repairs of the drains

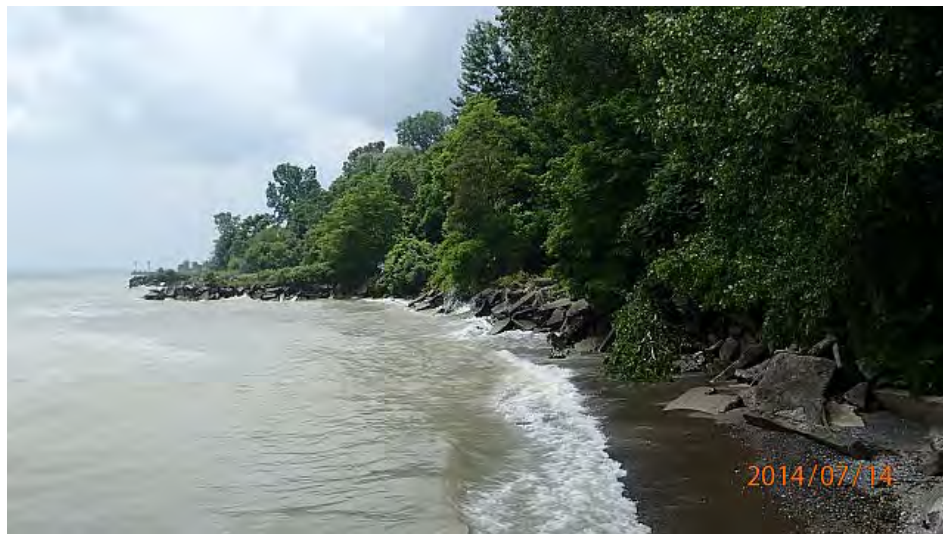
The shoreline in Reach 2 is protected by dumped concrete rubble, as seen in Figure 5.5. Beaches are very narrow or non-existent. While dense vegetation exists behind the concrete rubble, this should not be confused as an indication of a stable beach and bluff. Numerous active groundwater seeps

were observed at the base of the bluff and future geotechnical engineering studies may be required to investigate slope stability hazards.

Figure 5.5 Concrete Rubble Shoreline Protection East of Navigation Channel, Port Glasgow

The ownership of this structure should be ascertained by the landowners and a regular maintenance schedule developed. During high lake levels, the deteriorating concrete rubble will provide minimal erosion protection and the existing trail will be susceptible to erosion. If this ad hoc erosion protection structure fails, then the bluff behind will be very susceptible to erosion and slope failures.

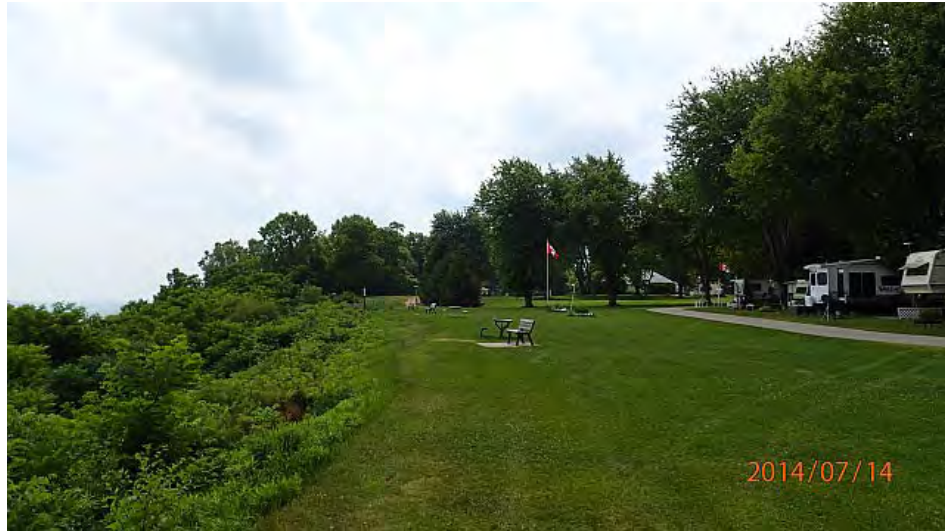
Above the vegetated bluffs in Reach 2, the tablelands are occupied by two trailer parks. In general, the roads and trailers are set back from the bluff crest and not within the Zone of Higher Risk (3:1 Stable Slope Line). Refer to Figure 5.6. However, three locations are noted on Figure 5.7 (white arrows) where a private road and/or trailers are within the Zone of Higher Risk. The bluffs should be regularly monitored in these locations.

Figure 5.6 Buffer Strip between Vegetated Bluff Crest and Road/Trailers

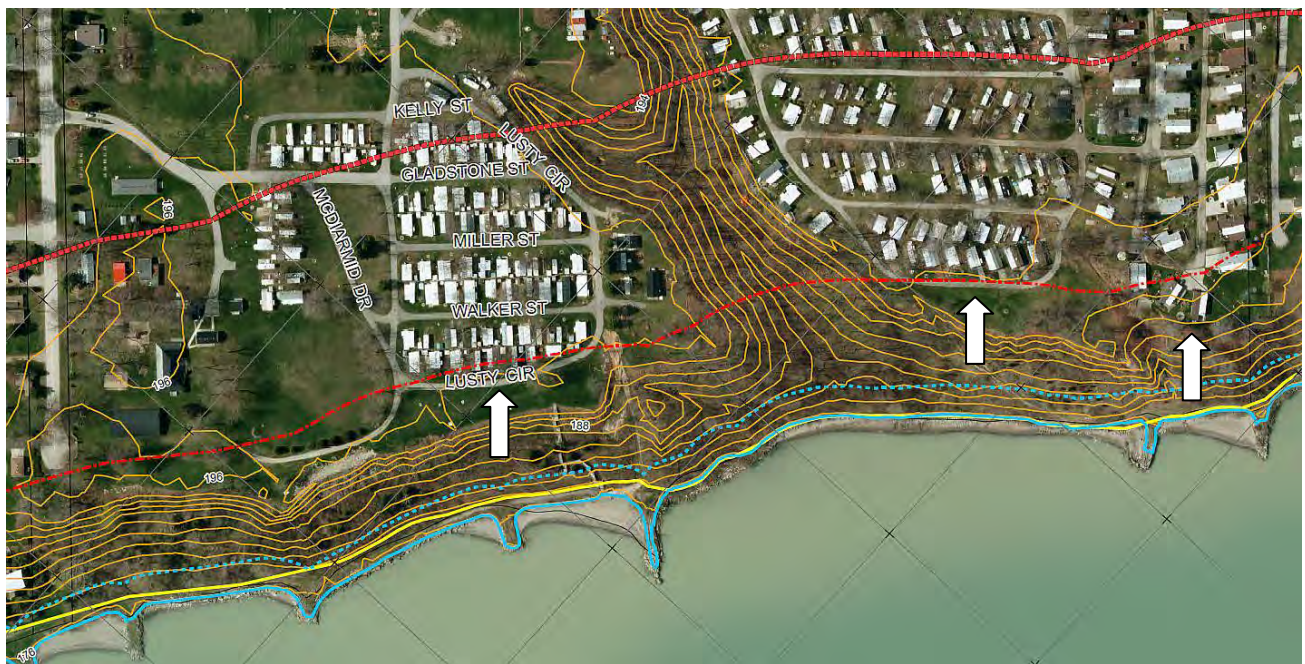
Figure 5.7 3:1 Stable Slope (red dash-dot line) and 100 Erosion Hazard Setback (red dashed line). White Arrows Identify Roads/Buildings in the Zone of Higher Risk

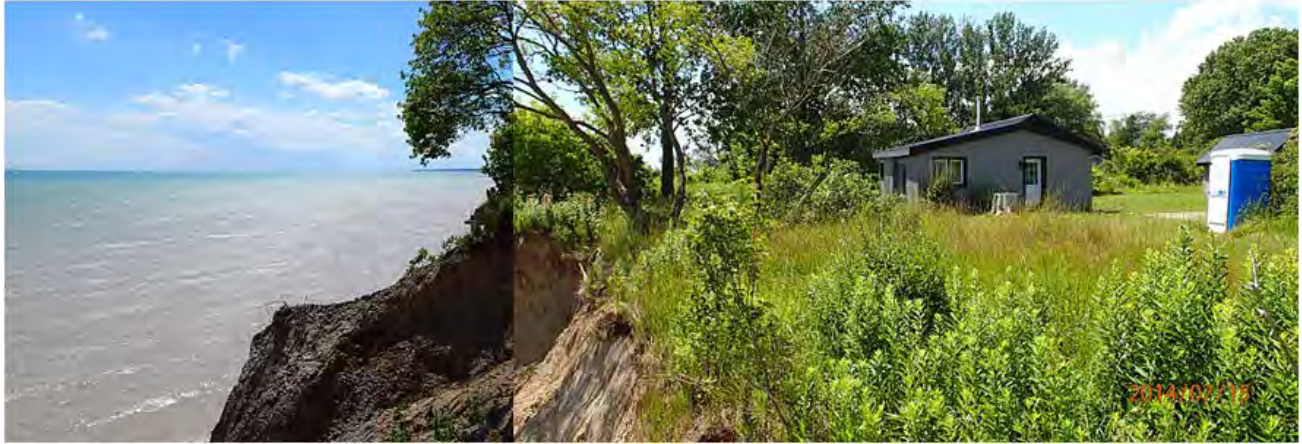
Figure 6.4 Building in Close Proximity to the Eroding Bluff Crest

No development is safe within the 3:1 stable slope setback and as such, owners of such assets (e.g. buildings) should be notified. A new policy could be developed in keeping with the Elgin County Emergency Response Plan and local zoning bylaws that prohibit occupation of such dwellings, particularly those within 10 m of the bluff crest (the Zone of Pending Failure). At any time in the future, the land within this zone and any assets could be completely lost in the next bluff failure. Due to the severity of these hazards, it is advised that all activities be directed to a location further inland, including recreational pursuits, trails, temporary parking, sitting of mobile recreational vehicles, etc. Refer to Figure 6.4 for an example of a residence in close proximity to the eroding bluff crest.

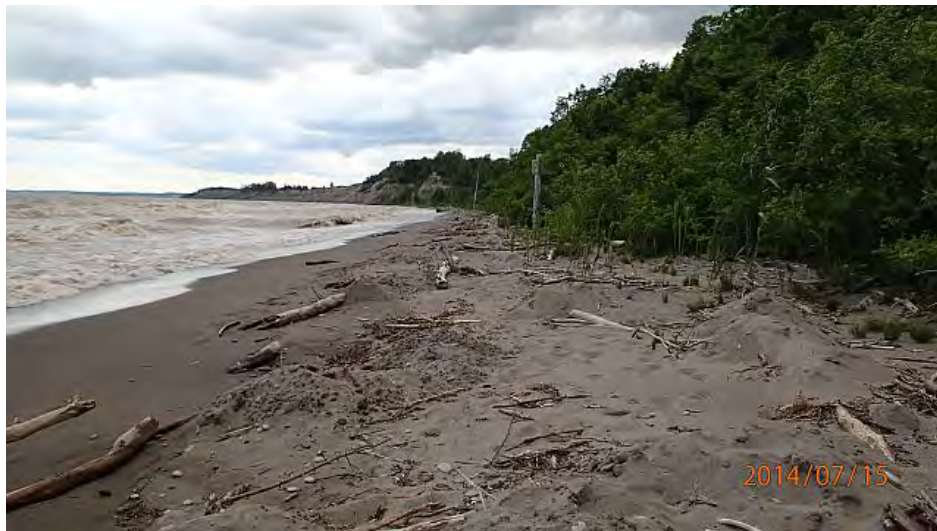
KCCA Reach 1 is a transition area from the eroding high bluffs to the west and the stable fillet beach in Port Stanley to the east. Refer to Figure 6.2 for the limits of Reach 1 and Figure 6.5 for a ground level picture. At present, the sand beach is narrow and disappears at the western limit of the Grand Canyon Ravine. Although the back of the beach is heavily vegetated with pioneer shrubs and small trees, the eroding bluff crest is still visible in many locations. Refer to Figure 6.6 for an example. The lack of mature trees on the bluff slope indicates that the period of stability along the beach has been relatively short lived in Reach 1.

Figure 6.5 Narrow Beach in KCCA Reach 1

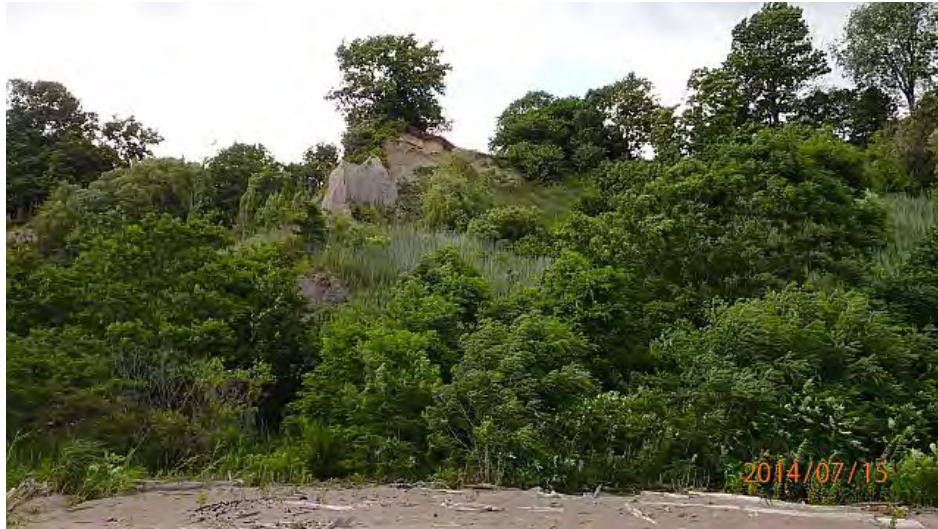
the accreting fillet beach. In other words, the shoreline trend has changed from erosion to accretion. However, it is also important to note that Lake Erie has been in period of low to average lake levels for the last 15 years. If high lake levels return, the recently accreted beach in Reach 1 could erode leaving the bluff toe and slope susceptible to wave attack and erosion.

Figure 6.6 Former Eroding Bluff Crest in KCCA Reach 1

The recommended management approach for KCCA Reach 1 is maintenance of the natural vegetation at the back of the beach and on the bluff slope. Over time, the vegetation will help stabilize the slope and bluff crest. However, until the beach width increases dramatically, Reach 1 should be monitored on an annual basis. In addition, only a narrow sliver of bluff separates the Grand Canyon Creek from the open lake at the western end of Reach 1. When this section of bluff erodes, the opening to the creek valley will increase dramatically, further jeopardizing the development along Grand Canyon Road.

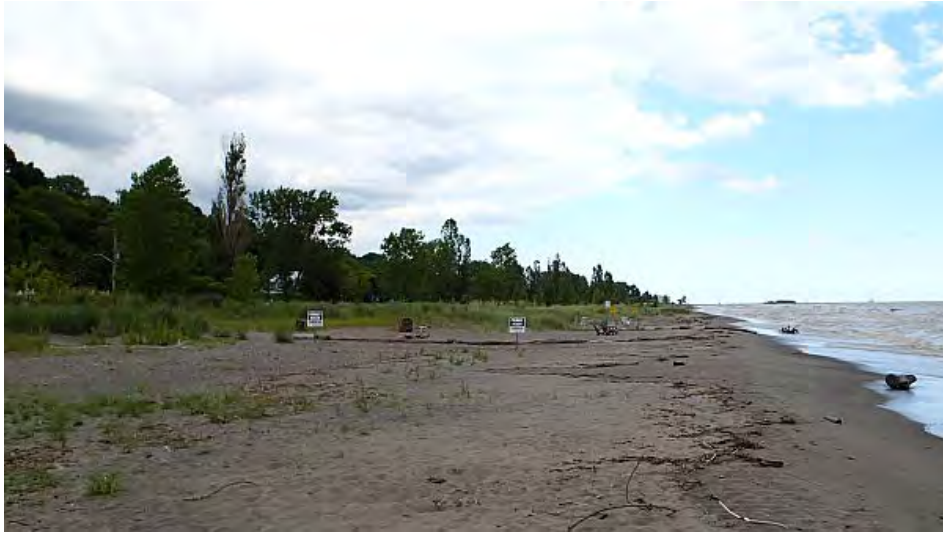
Reach 2 is a 1.8 km long fillet beach on the western side of the navigation channel in Port Stanley. The western portion of Reach 2 features less residential development and more natural beach and dune conditions. Refer to Figure 6.7. The beach width increases in an easterly direction as does the degree of residential and commercial development. The dunes are smaller or absent completely for the eastern half of Reach 2. Refer to Figure 6.8.

Figure 6.7 Beach and Dune Conditions in the Western Half of KCCA Reach 2

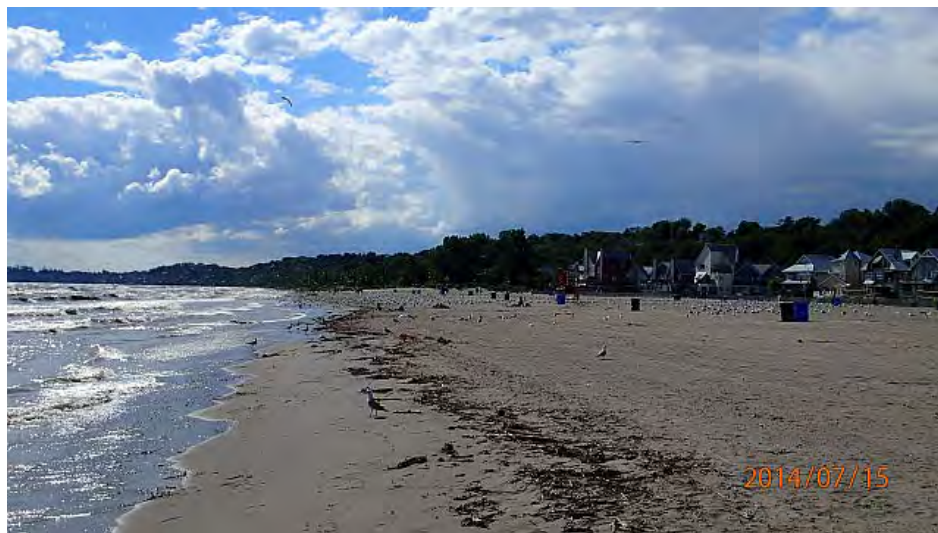
Figure 6.8 Wide Beach Conditions in the Eastern Half of KCCA Reach 2

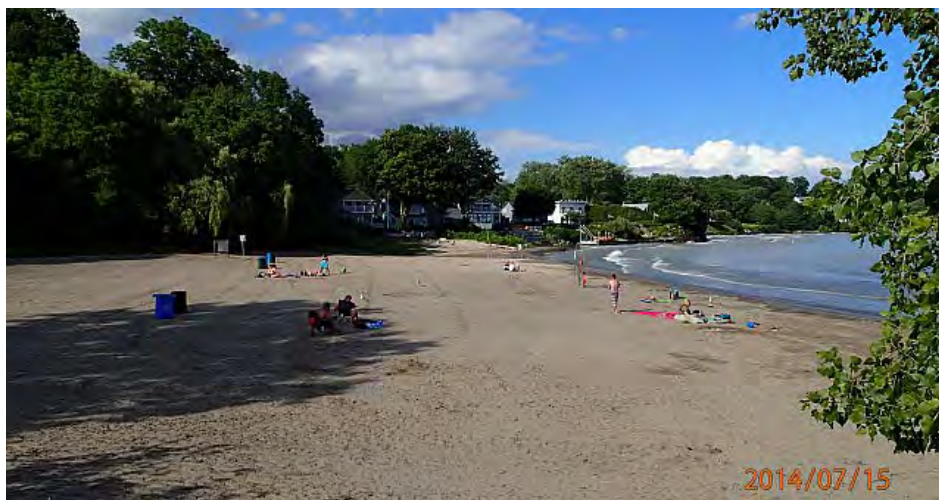
Little Beach is located on the eastern side of the harbour jetties and features a wide gently sloping beach at the present lake level. During higher lake levels, the waterline will migrate inland significantly. The previous SMP (Philpott, 1989) suggests the beach was formed with sediment dredged from the navigation channel. Present management practices with the dredged sediment are unknown but a stockpile was observed in the parking lot adjacent to Little Beach. When the winds are from the west and southwest, Little Beach provides a sheltered alternative to the main beach at Port Stanley in Reach 2. The beach should be maintained in the future for public access to Lake Erie. The promotion of dune vegetation is encouraged to increase the elevation of the beach, which will help mitigate the potential negative impacts of a prolonged period of high lake levels. Alternatively, an artificial dune restoration project could be planned and executed at Little Beach.

Figure 6.9 Little Beach in Port Stanley, Looking East

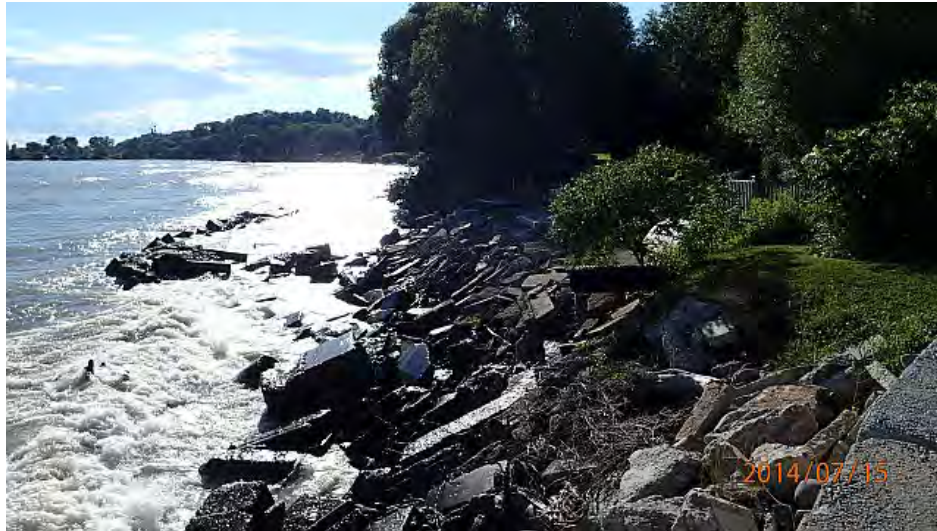
KCCA Reach 4 features high density residential development and shoreline protection structures at the water's edge. During the July 2014 field visit, no beaches were observed in Reach 4. Refer to Figure 6.10 for a typical picture of the shoreline conditions. Without the shoreline protection, this reach would feature a long-term erosion rate. Therefore, it is imperative that the riparian landowners regularly inspect their existing shoreline protection and complete maintenance when required.

Figure 6.10 Existing Dumped Concrete Rubble in KCCA Reach 4

In the future, shoreline protection maintenance will be required to address degradation of these structures, and should be permitted provided the repair or replacement are contained within the footprint of the present structure. New shoreline protection structures are not recommended for Reach 4. However, limited types of new development are permitted in the erosion hazard area provided they are supported with the appropriate technical studies. Given that site access for construction equipment will be a challenge due to the high density development and lack of beach, a coordinated maintenance project across the entire length of Reach 4 should be pursued. Not only will a single engineered approach be more successful in the long-term, it will be more cost effective.

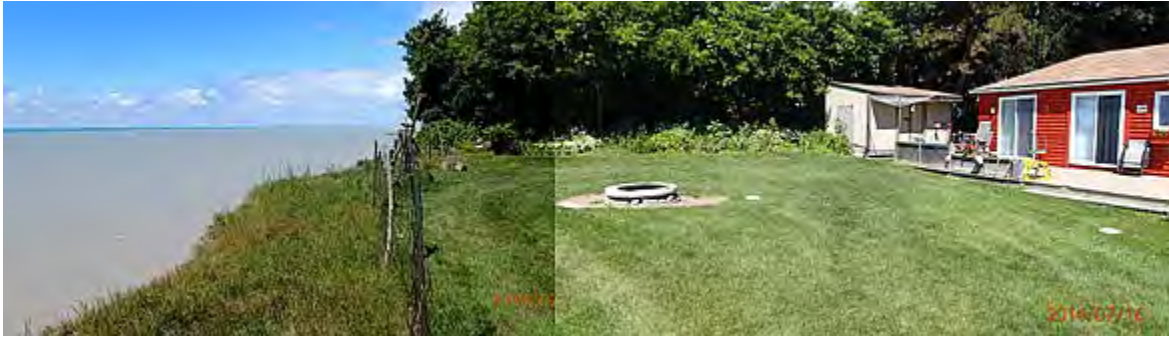
Figure 7.4 Building with 3:1 Stable Slope Setback

No development is safe within the 3:1 stable slope setback and as such, owners of such assets (e.g. buildings) should be notified. A new policy could be developed in keeping with the Elgin County Emergency Response Plan and local zoning bylaws that prohibit occupation of such dwellings, particularly those within 10 m of the bluff crest (the Zone of Pending Failure). At any time in the future, the land within this zone and any assets could be completely lost in the next bluff failure. Due to the severity of these hazards, it is advised that all activities be directed to a location further inland, including recreational pursuits, trails, temporary parking, sitting of mobile recreational vehicles, etc. Refer to Figure 7.4 for an example of a residence in close proximity to the eroding bluff crest.

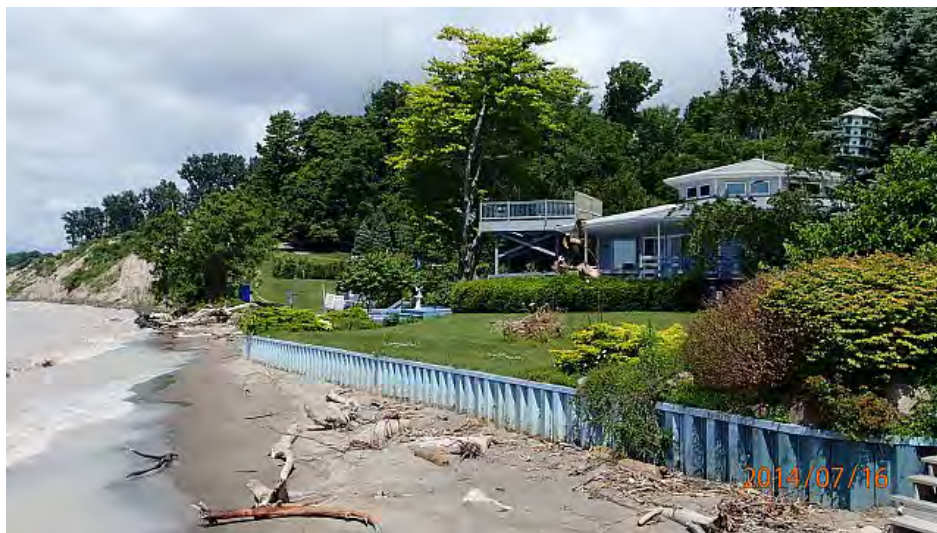
The shoreline position in the western 200 m of CCCA Reach 1 has been artificially stabilized with a series of private steel sheet pile walls protecting the residential development. Refer to Figure 7.5 for a picture of a typical structure. The eroding bluffs west of Waneeta Beach Road are visible in the background of the photograph. As the shoreline continues to migrate further inland towards Dexter Line, these vertical steel sheet pile walls will be susceptible to flanking erosion and lakebed downcutting, and thus should be monitored on an annual basis.

Figure 7.5 Steel Sheet Pile Wall Protecting Residential Development in CCCA Reach 1

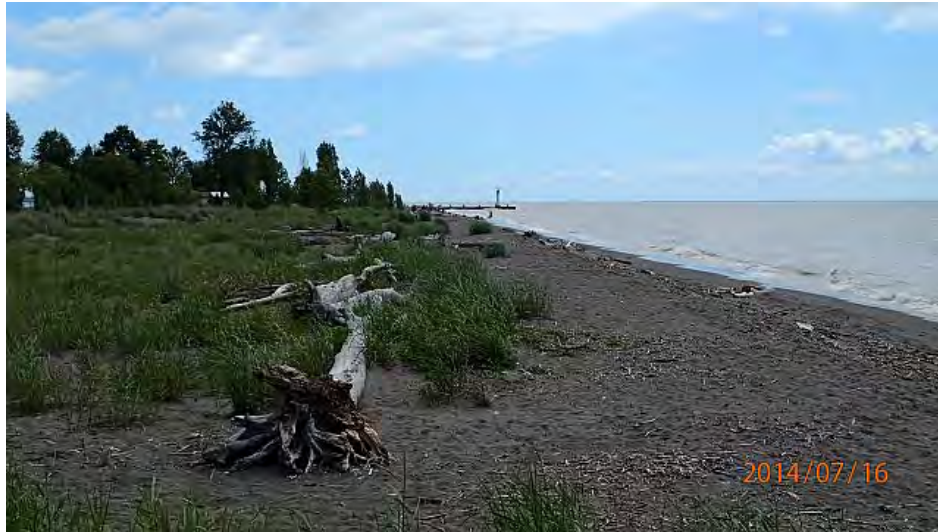
Figure 7.6 Beach and Dunes at Port Bruce Provincial Park

The beaches and dunes in the Provincial Park are protected from development and provide a natural barrier to Imperial Road. Beach goers should be encouraged to access the lake from a series of existing trails to avoid damage to the fragile dune vegetation.

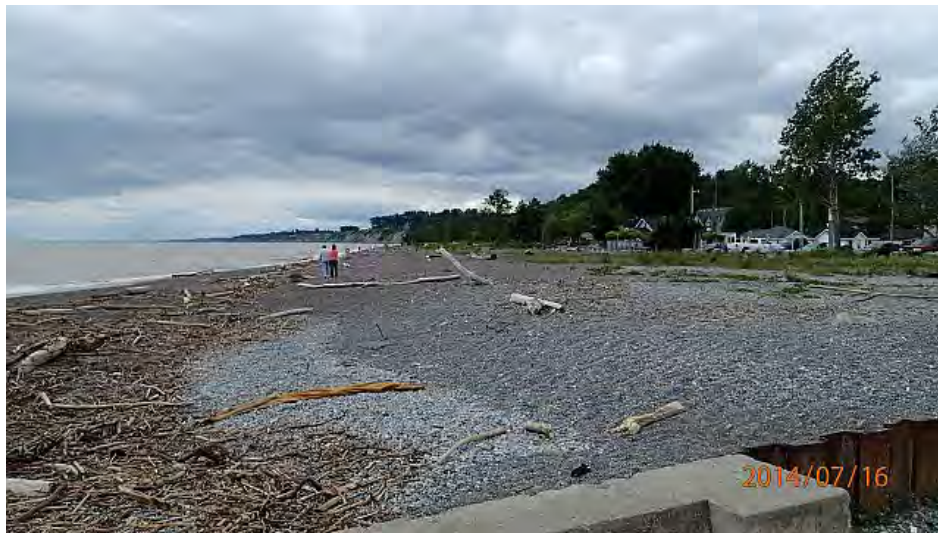
Figure 7.7 Fillet Beach in Port Bruce Adjacent to the Western Jetty

The eastern limit of CCCA Reach 1 features a public beach and access to the western jetty at the rivermouth. The development at the back of the beach is separated with a narrow strip of dune vegetation. Foot traffic should be directed away from this vegetated area, as it provides important flood protection during Lake Erie storms and if the dune was permitted to grow in elevation, it would provide more effective flood protection.

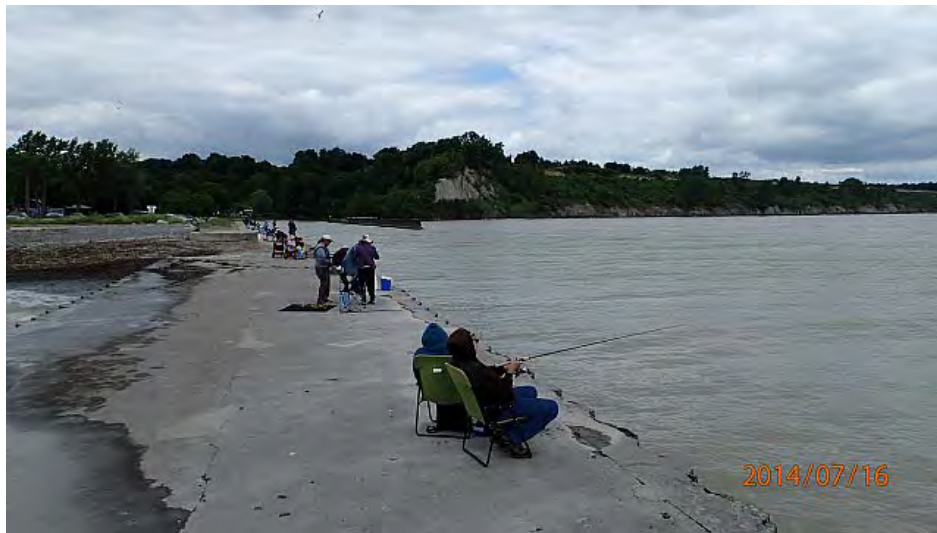
Figure 7.8 Western Jetty in Port Bruce

The jetties and navigation channel are the predominate feature in CCCA Reach 2. The jetties are a popular fishing destination and represent an important access point to the Lake Erie shoreline. Refer to Figure 7.8. The eastern jetty consists of a single steel sheet pile wall and terminates into the eroding bluff. The position of the bluff toe and riverbank are protected with rip rap. This protection should be inspected at least annually, as its continued existence is critical to maintaining a protected and stable navigation channel. If the protection fails and bluff erosion commences, then the existing steel sheet pile wall will be separated from the shore and the river will have two outflow channels.

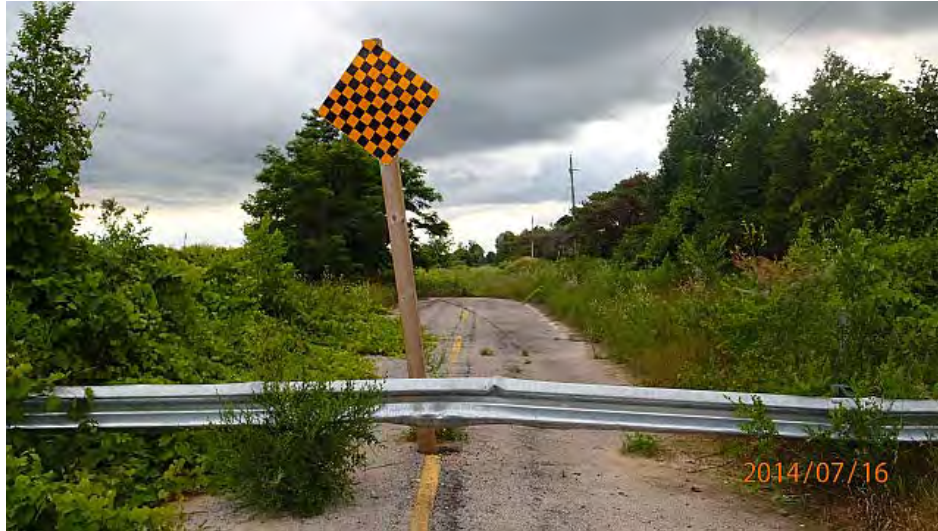
Figure 8.5 Section of Lake Shore Line Closed Due to the Erosion Hazard

The majority of the lands east of Port Burwell are rural and used predominantly for agriculture. Lake Shore Line is already fragmented in several locations due to the retreating bluffs. Soon the north-south road network will be the only access points to the shoreline. The implications for the local transportation network and emergency access should be evaluated.

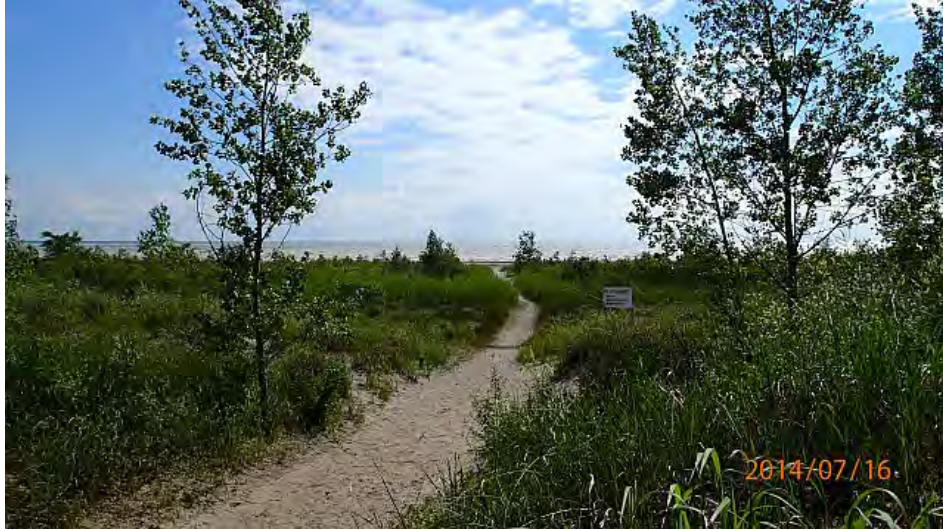
Figure 8.6 Controlled Beach Access within Port Burwell Provincial Park

Access to the beach within the Provincial Park is already controlled via identified access routes. Refer to Figure 8.5. Directing the beach goers to these dedicated access trails to reach the water's edge eliminates foot traffic on the sensitive dune species.

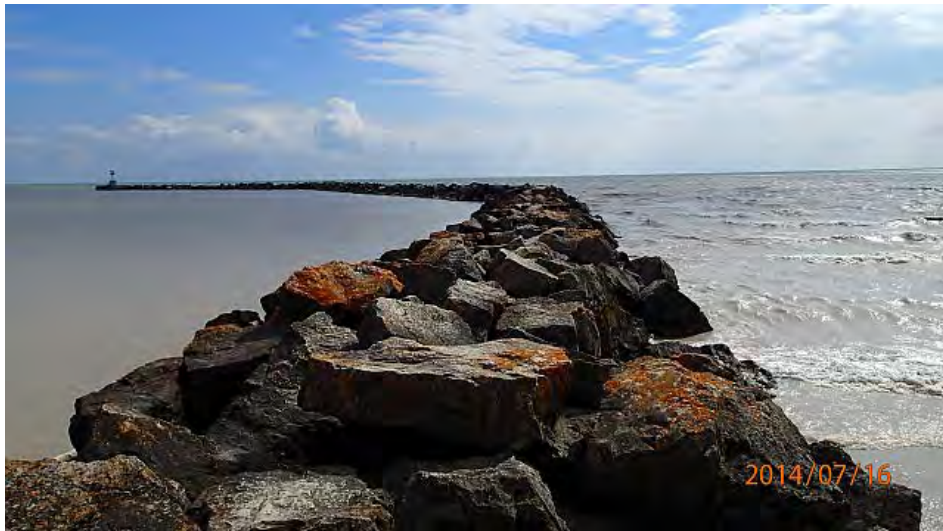
Figure 8.7 Armour Stone Jetty Extension (west jetty) at Port Burwell

LPRCA Reach 2 consists of the engineering structures and navigation channel at the mouth of Big Otter Creek. The western jetty is approximately 800 m longer than the eastern jetty, which creates a sediment trap for sand and gravel moving east to west along the shoreline. In addition, it is possible that fine sediments transported down the river are deposited in this region. A picture of the western armour stone jetty is provided in Figure 8.7.

The channel depths in the Big Otter Creek and near the tip of the eastern jetty should be regularly monitored to ensure the river is capable of conveying the spring floods and other high flow events to minimize the potential for localized flooding.

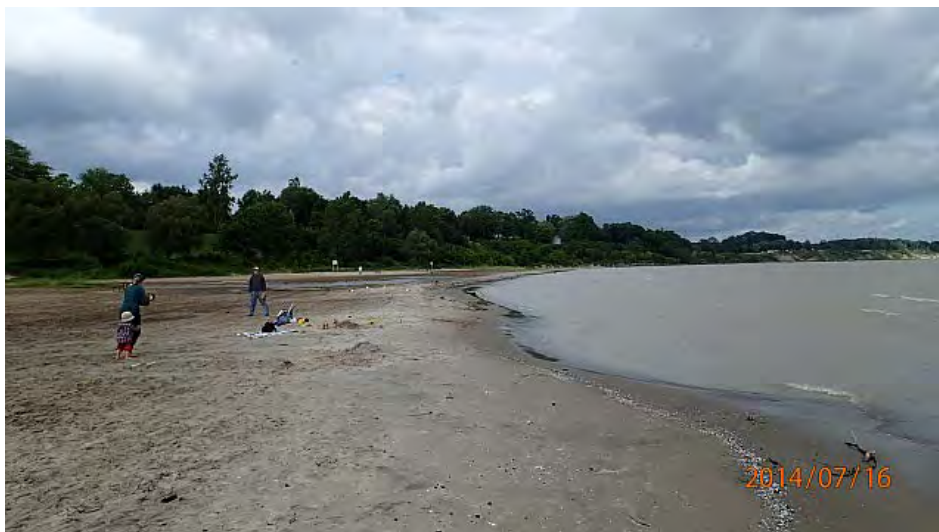
Figure 8.8 Eastern Fillet Beach at Port Burwell

LPRCA Reach 3 is approximately 1.2 km in length and consists of the smaller eastern fillet beach at Port Burwell and dense residential development located landward of the bluff crest. Refer to Figure 8.8. With the present lake level conditions in 2014/2015 (e.g. average), the fillet beach is approximately 600 m in length. However, as seen in Figure 8.8, the beach has a very flat slope and overall features a low elevation profile (especially when compared to western fillet beach in the Provincial Park). When high water levels return to Lake Erie, a significant portion of the sand beach will be submerged, thus reducing the size of the dry beach.

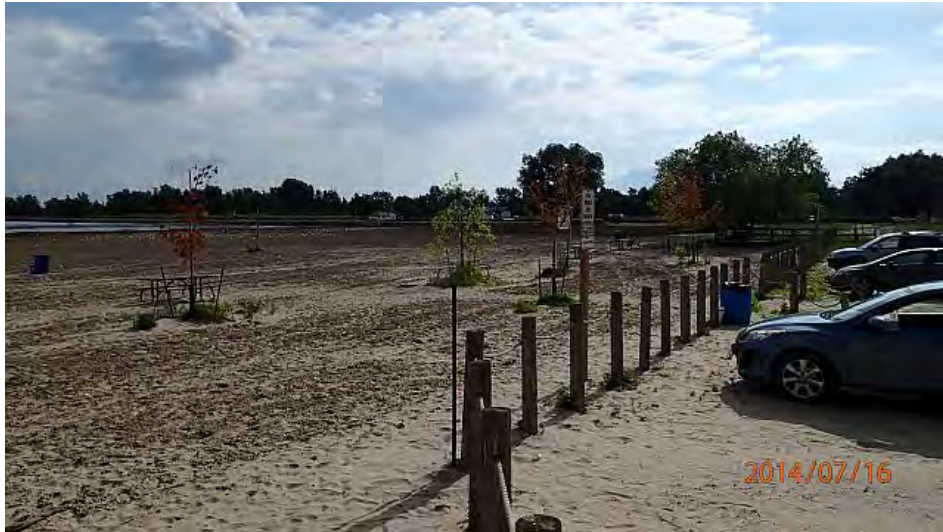
Figure 8.9 Transition from Eastern Fillet Beach to Parking Lot

The conditions at the back of the beach and adjacent parking lot are presented in Figure 8.9. Similar to the water's edge, the area is very flat and low lying. It also appears the beach is raked or manicured in some way, which would explain the lack of any native dune species. If the beach was maintained in a natural state and access was controlled/limited to select walkways, natural dune vegetation would colonize the back of the beach, encourage the deposition of sediment and raise

the overall volume of sand stored at the back of the beach. This in turn would increase the flood and erosion protection provided by the beach, and enhance local habitat. A future restoration project should be pursued by all stakeholders.

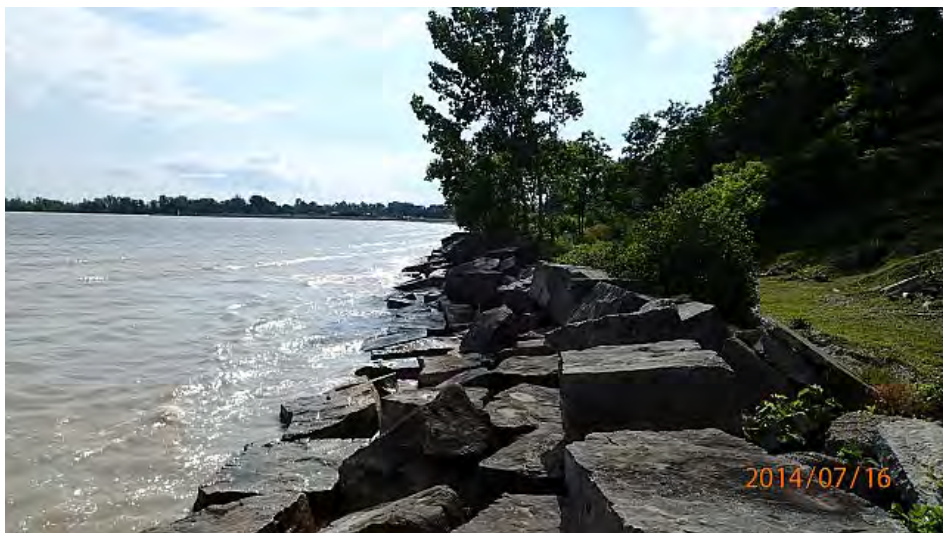
Figure 8.10 Armour Stone Revetment at the Foot of Pitt Street

The remainder of LPRCA Reach 3 is protected by a long armour stone revetment. A picture of a typical section is provided in Figure 8.10. The ownership of this structure should be ascertained and a regular maintenance program should be developed. It provides critical erosion protection to the high density development located landward of the bluff crest. However, as documented in Section 4.4, these types of shore parallel structures do not stop lakebed downcutting in front of the structure and thus they are susceptible to toe failures.
