Elgin County Shoreline Management Plan

October 13, 2015
12251.101

W.F. Baird & Associates Coastal Engineers Ltd.

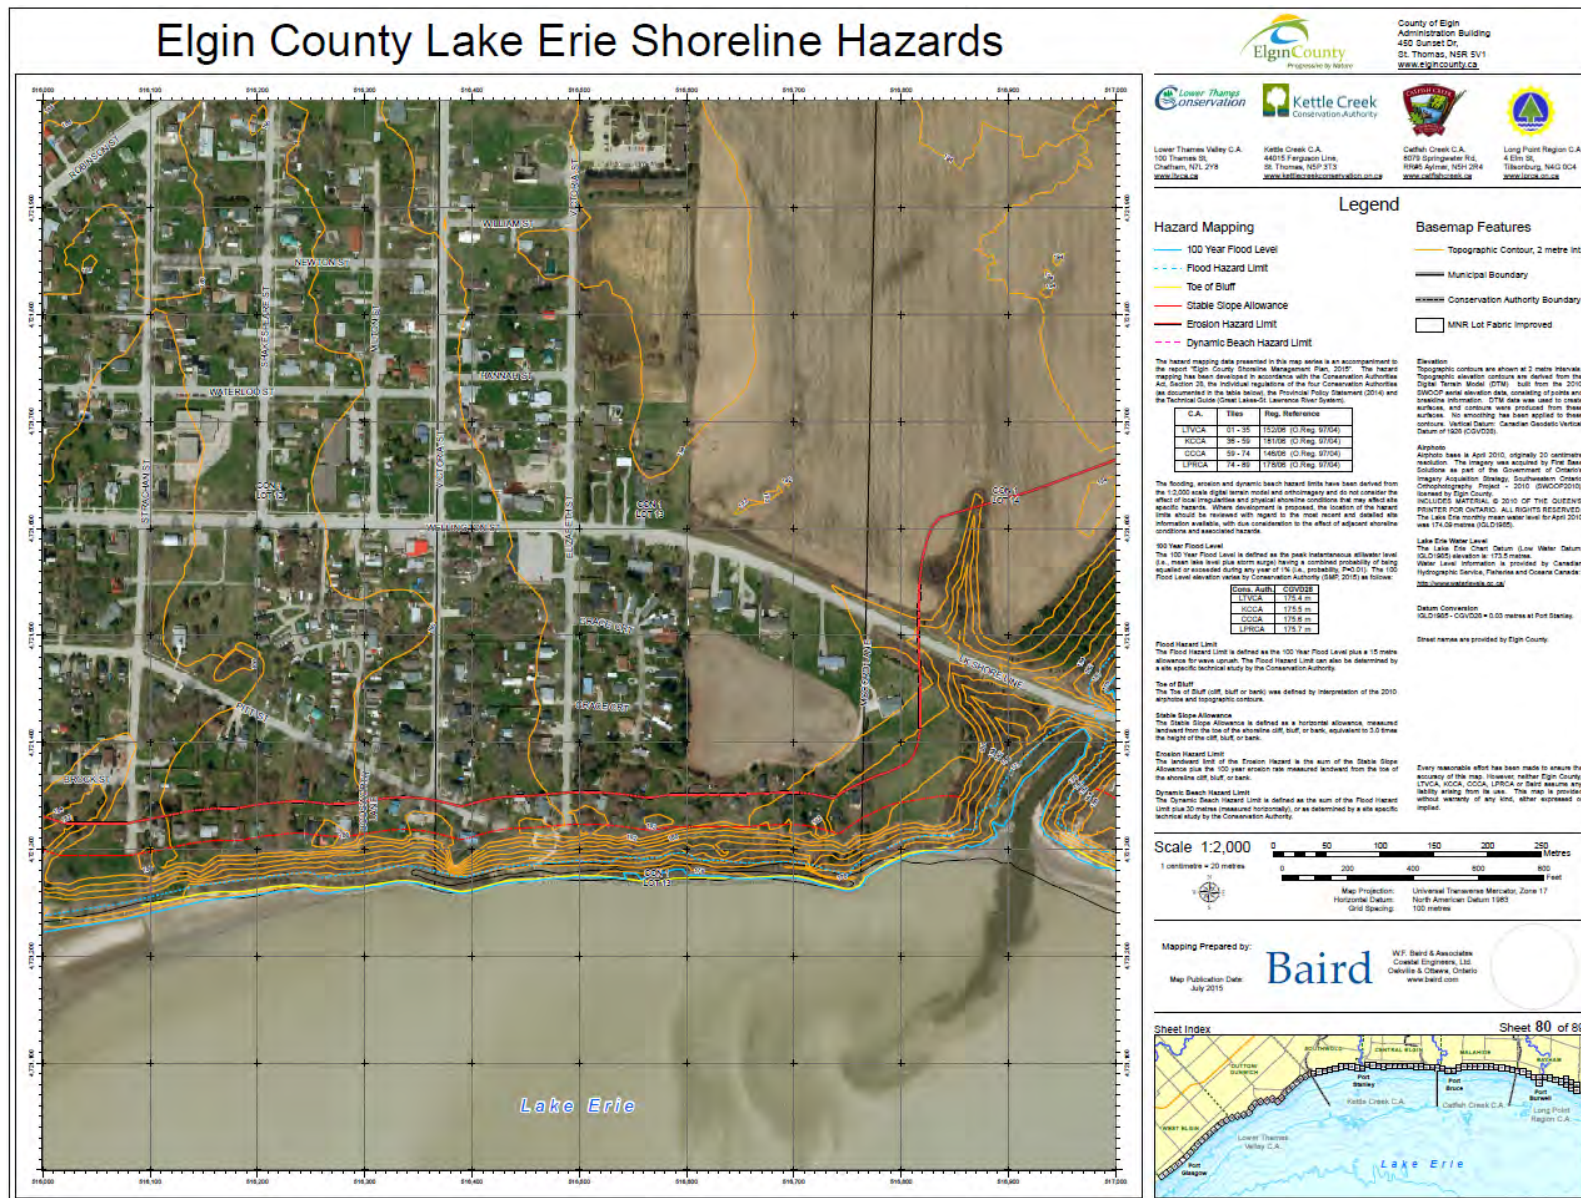
Figure 8.11 Sheet 80 East of the Big Otter Creek in Port Burwell

The hazardous lands for the LPRCA Lake Erie shoreline are mapped on Sheets 74 to 89, and are provided in Appendix G. The erosion, flooding and dynamic beach setbacks are depicted on the maps, collectively defining the hazardous lands along the Lake Erie shoreline for the LPRCA. The flooding hazard is defined by the 100 year instantaneous lake level (175.7 m, CGVD'28) plus a 15 m horizontal setback. The dynamic beach setback includes an additional 30 m, measured landward, from the flood hazard limit.

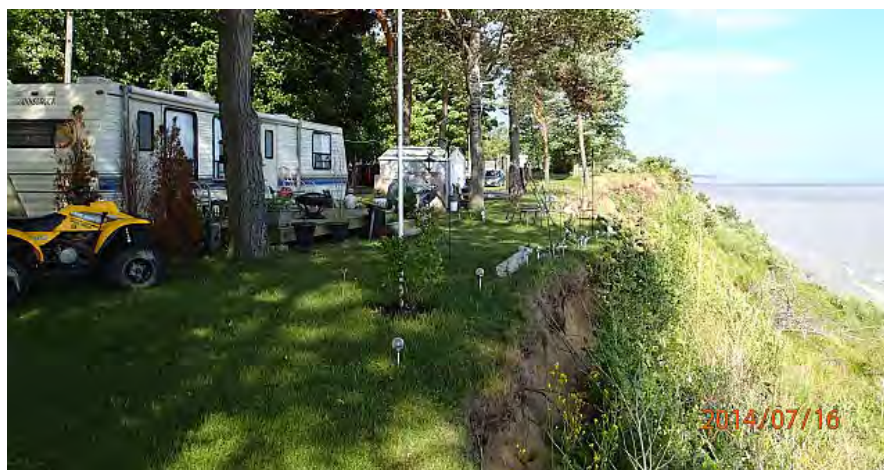
Figure C.2 Trailers Located in Close Proximity to the Bluff Crest

approximately 100 m and there has been substantial land loss in this region of Elgin County. Refer to Figure C.2 for a picture of the lakeward most row of trailers. At present, there is no formal programme (e.g., bylaw, policy, legislation) in place to notify these individuals of the risks they face and relocate these assets before they are lost in the next bluff failure.

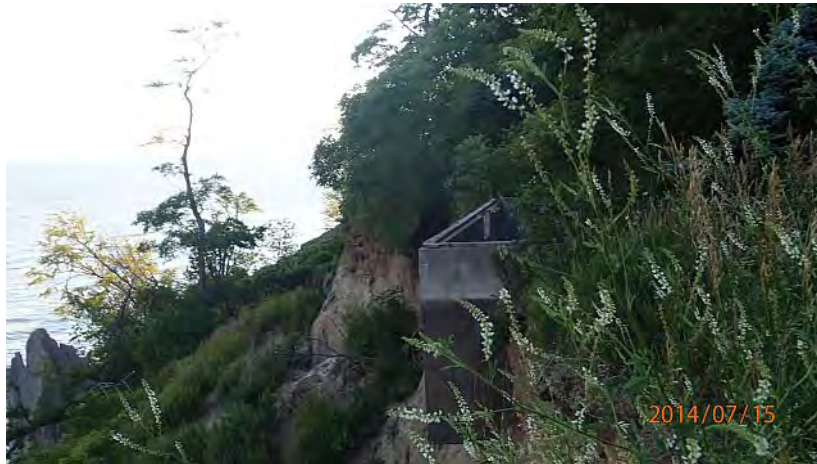
Figure C.3 Concrete Foundation from Abandoned House Exposed in Bluff Crest

A related issue is decommissioning relocated or abandoned buildings. For example, refer to the poured concrete building foundation in Figure C.3 and the old buried fuel tank in Figure C.4. Without a formal policy to ensure the orderly and thorough decommissioning of residences, buildings, utilities, etc. when threatened by erosion, unwanted debris will eventually end up in the lake with potentially serious environmental consequences.
