Chatham-Kent Lake Erie Shoreline Study

The Municipality of Chatham-Kent

May 25, 2020

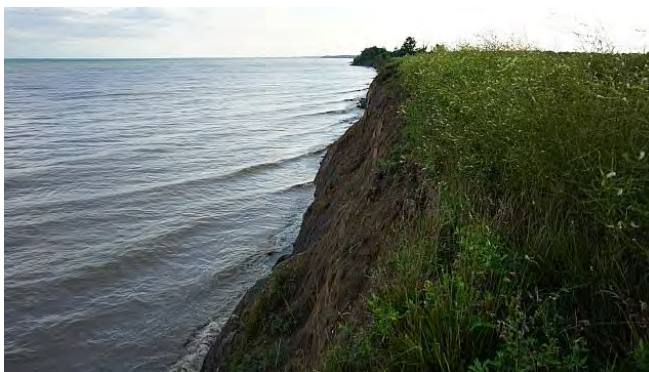
Figure 2.15 Bluff Line August 2018

The shoreline in Region 1B is dominated by eroding bluffs that exceed 20 m in elevation in most locations. The steep bluff face along Bluff Line in August 2018 is presented in Figure 2.15. Two images of the eroding bluffs in the Port Alma area are presented in Figure 2.16 and 2.17. Waves continually undercut the toe or base of the bluffs, leading to upper slope failures.

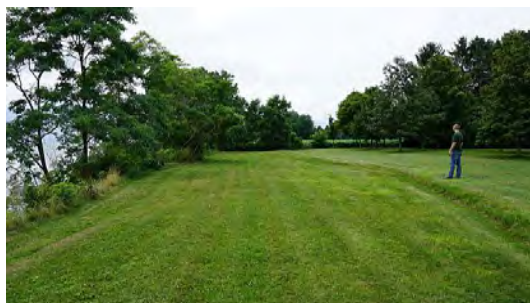
Figure 2.18 Offset in the Tablelands Due to a Deep-seated Rotational Failure

The impacts of storms and wave attack on the bluff toe are obvious signs of the severity of the long-term erosion rate in Region 1B. However, erosion is not limited to the bluff face. It happens on the lake bottom and is known as lakebed downcutting. It also happens on the bluff slope and on the table lands in response to the toe erosion. Refer to Figure 2.18, where the signs of a deep-seated rotational failure are evident in the mowed yard (i.e., the 1 ft offset where the gentleman is standing is the start of a large block failure). These deep-seated failures are first observed on the tablelands but can extend all the way to the lake level and below. As these failures progress downslope, they form tension cracks as the block of soil separates from the inland. Eventually large pieces of the bluff fall into the lake (see tension cracks in Figure 2.19 and 2.20).

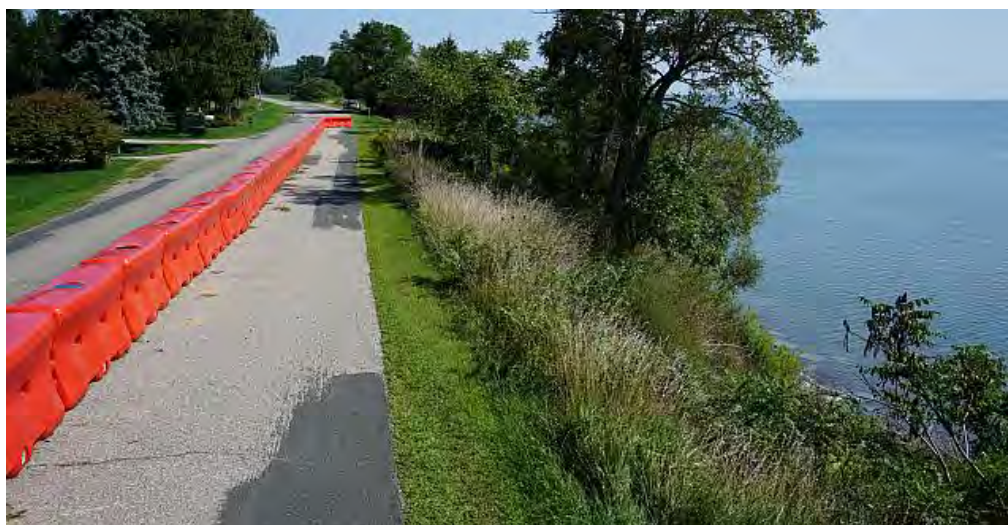
Figure 2.22 Road Closure on Rose Beach Line

Region 1D marks the beginning of the bluff shoreline northeast of Rondeau Bay. A picture of the eroding bluffs and road closure along Rose Beach Line is provided in Figure 2.22. At the base of the eroding clay bluffs, dumped concrete rubble was observed, as seen in Figure 2.23.

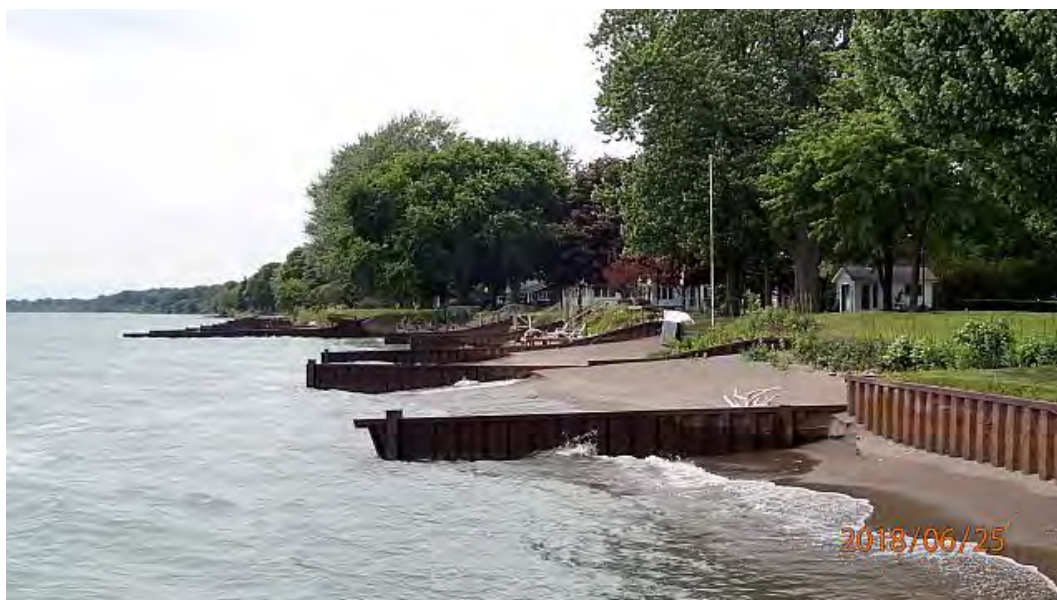
Figure 2.26 Steel Sheet Pile Groynes at Erie Beach

The Erie Beach community is approximately 1.5 km in length and is protected with near continuous steel sheet pile groynes and seawalls at the back of the beach. Refer to Figure 2.26 for a picture of the typical shoreline conditions. Figure 2.27 highlights the potential for erosion between the groynes if the low bank is not protected.

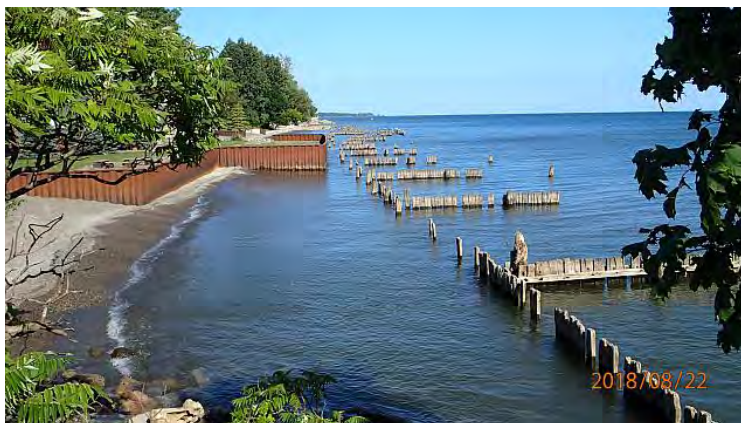
Figure 2.28 Old Timber Groynes and New Steel Sheet Pile Wall (2018.08.22)

Pictures of Erie Shore Drive during non-storm conditions are provided in Figure 2.28 (old timber groynes) and Figure 2.29 (concrete rubble shore protection). Images from the August 27, 2019 flooding event at Erie Shore Drive are presented in Figures 2.30 to 2.32. Extensive flooding

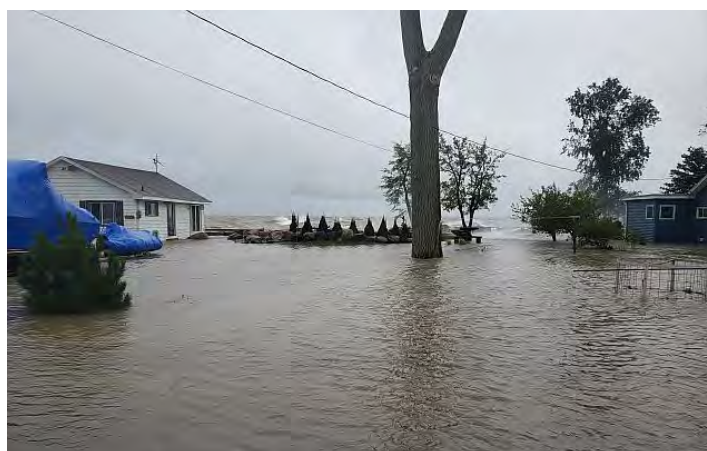
Figure 2.30 Flooding of Building Foundations, August 27, 2019 Storm

occurred around home foundations, structural damage occurred in some locations due to wave forces, and septic tile beds were in failure due to the yard flooding. In locations where Erie Shore Drive is low, sheet flow conveyed water over the road and into the Lakeshore Drain. Erosion of the north dike slope occurred in several locations, threatening the stability of the road and dike crest.

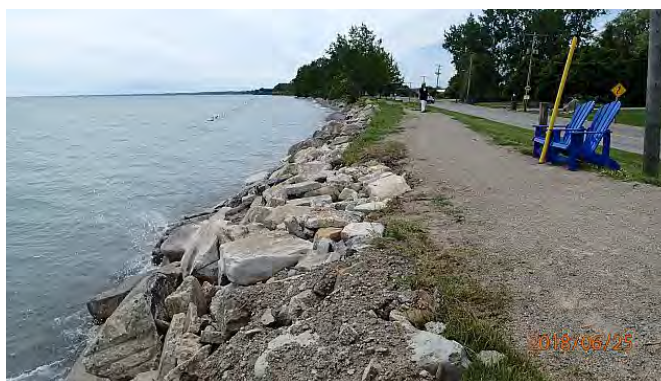
Figure 2.33 Armour Stone and Concrete Rubble in front of Dike, St. Anne's Church

The Village of Erieau features a variety of shoreline conditions and different exposures to coastal hazards. A picture of the dike fronting Erieau Road at St. Anne's Church is provided in Figure 2.33. The wide sand beach west of the navigation channel is seen in Figure 2.34. The sheltered shoreline on the north side of Erieau is seen in Figure 2.35. The community is vulnerable to lake flooding, especially along Rondeau Bay (see Figure 2.36).

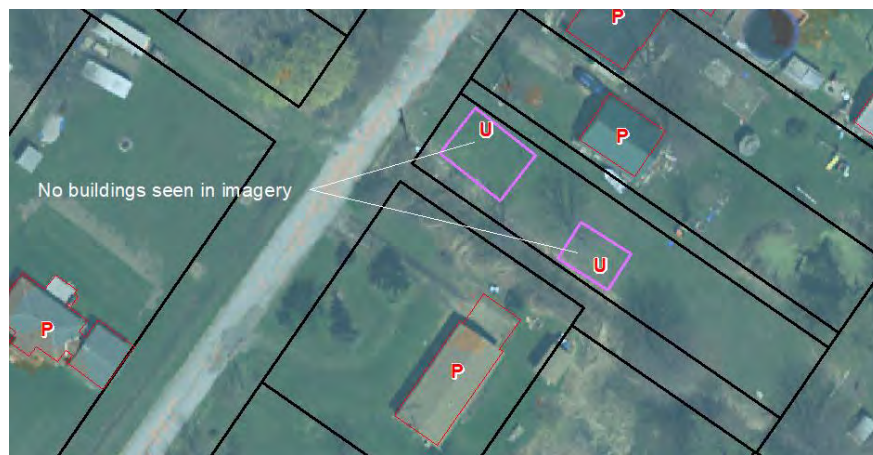
Figure 4.1 Example of Property Parcels and Building Footprints

1. The building polygon layer was reviewed for all areas susceptible to erosion and flooding along the Lake Erie shoreline. Missing building footprints were added or expanded as required to represent current conditions.
2. Buildings were attributed based on type, including primary (house), secondary (detached garage/out building), other (buildings <100 ft²), trailers/mobile homes, and unknown (could not be identified with aerial image, street view software, or no longer present). Refer to Figure 4.1 for an example of the property parcel data and building footprints.
3. A GIS function (join by location) was used to link buildings inside their appropriate property parcel.
4. The MPAC assessment values do not distinguish between land and building values. Therefore, algorithms were developed to assign weightings for the value to land, primary and secondary buildings.

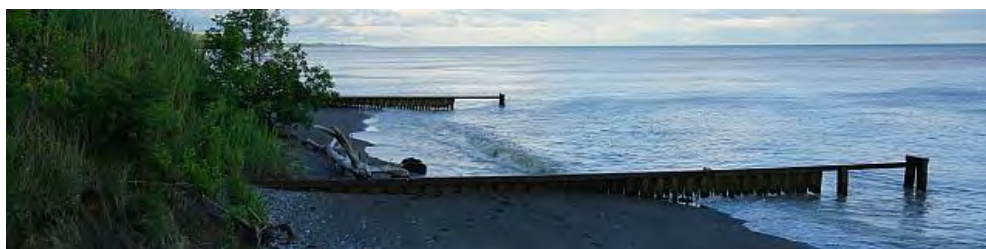
Figure 6.2 Steel Sheet Pile Groynes in Failure (top: sheet missing from the tip; bottom: vertical sheets corroded at the waterline)

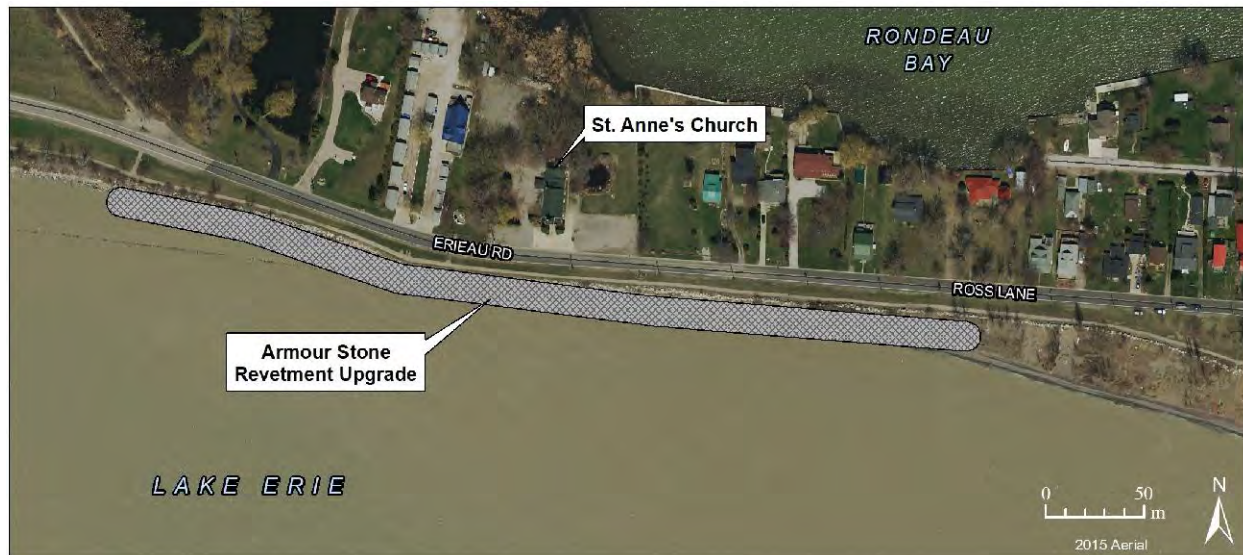
Figure 6.22 Extent of Armour Stone Revetment for Option 3-2

the climate change 100-year flood scenario. The cost range for Option 3-2 is \$4.6 to \$6.4 million, which includes the structure and road upgrades.
